# Service Bulletin

Bulletin No.: 23-NA-062

**Subject:** Rear View Camera Coaxial Related Issues – DTCs B395A, B395B, B395C, B101E, B101D

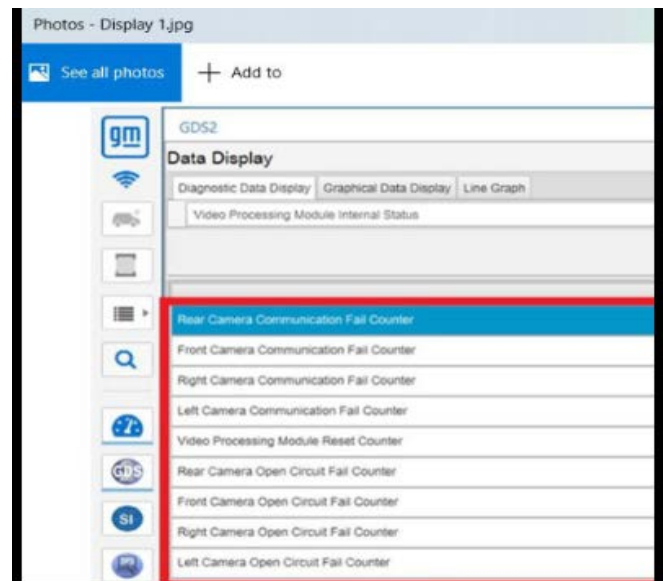
6083540

The VPM counters are listed in priority order from most usefulness to least. The ones outlined in red are considered the most critical and usually most helpful in root causing surround viewing issues.

3. The three most critical parameters to look at are:

- A. Camera Communication Fail Counter
- B. Video Processing Module Reset Counter
- C. Camera Open Circuit Counter

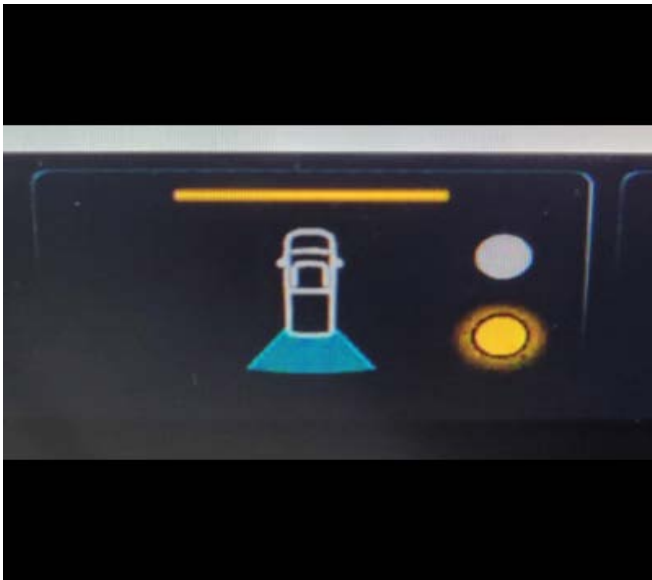
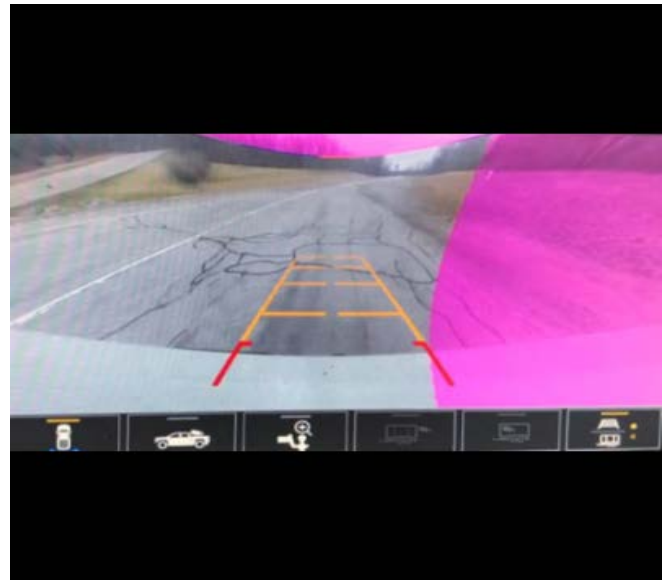
6083541

6. If it's difficult to determine the causal component, unplug all the cameras.
  - A. Leave the rear camera input and video output at VPM.
  - B. Activate the Rearview Camera (RVC) using the "Cameras" touch button.

- C. If there is no image output, swap to the front, left, or right cameras into VPM rear camera input and repeat previous steps to check images again.
- D. If concern(s) persist, refer to published diagnostics in SI.

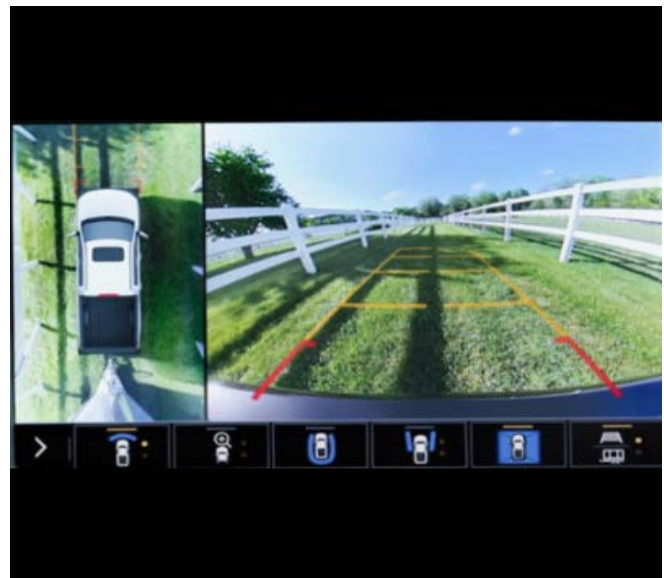
6083543

- If the “Cameras” Icon is greyed out and not working. The connection issue may be between the VPM and Radio.
- If the touch buttons are working properly, it could be an issue with the coax cable connection from the VPM to the Rear Vision Camera.

**Note:** Before testing the coax cable, check the cable's exterior for being pinched, cut, damaged, or having loose connections at the components, all of which can cause reception issues.

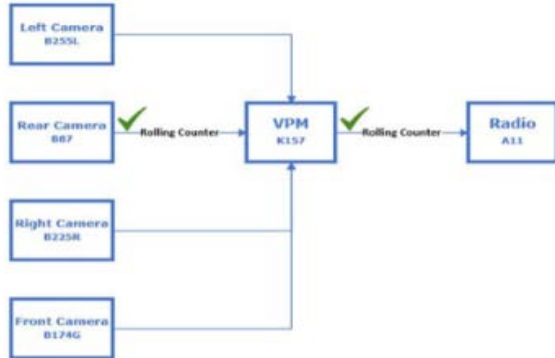
6083545

This rolling counter is monitored continuously to ensure we have video signal from the rear camera. It goes from the rear camera to the VPM and from the VPM to the radio.

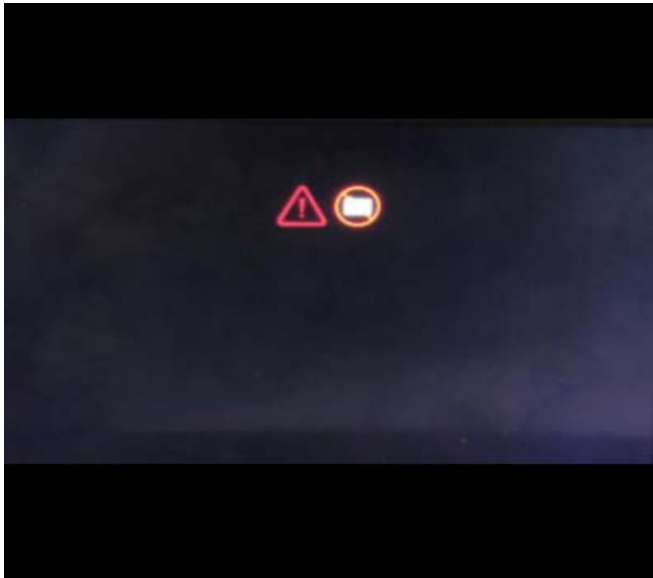
6083546

If the rear camera or the VPM do not provide the rolling counter, you will see the following black screen with an icon:

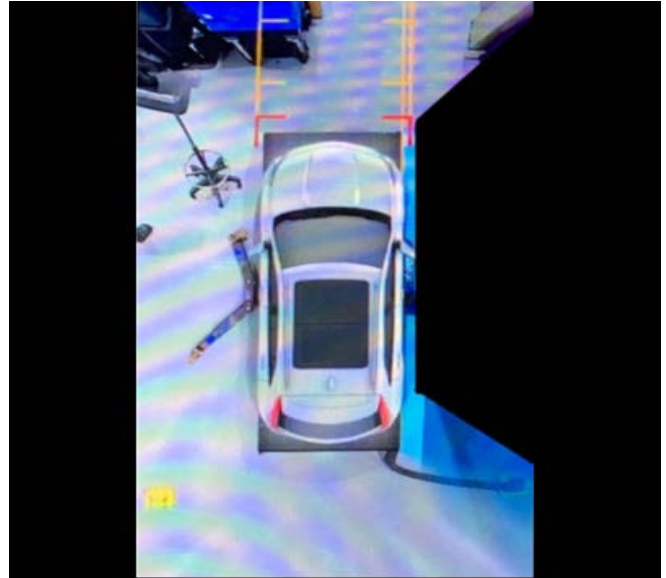
6083547

The VPM does not monitor the left, right or front cameras with a rolling counter. These camera's will display in black on their perspective side if there is an issue.

Figure below is of a right camera issue:
