REPORT NUMBER: NCAP305I-MGA-2018-003

**NEW CAR ASSESSMENT PROGRAM (NCAP)
FMVSS No. 305 Indicant Test**

**GENERAL MOTORS LLC
2018 Chevrolet Bolt EV LT 5-Door Hatchback
NHTSA No.: M20180100**

**MGA RESEARCH CORPORATION
5000 Warren Road
Burlington, WI 53105**

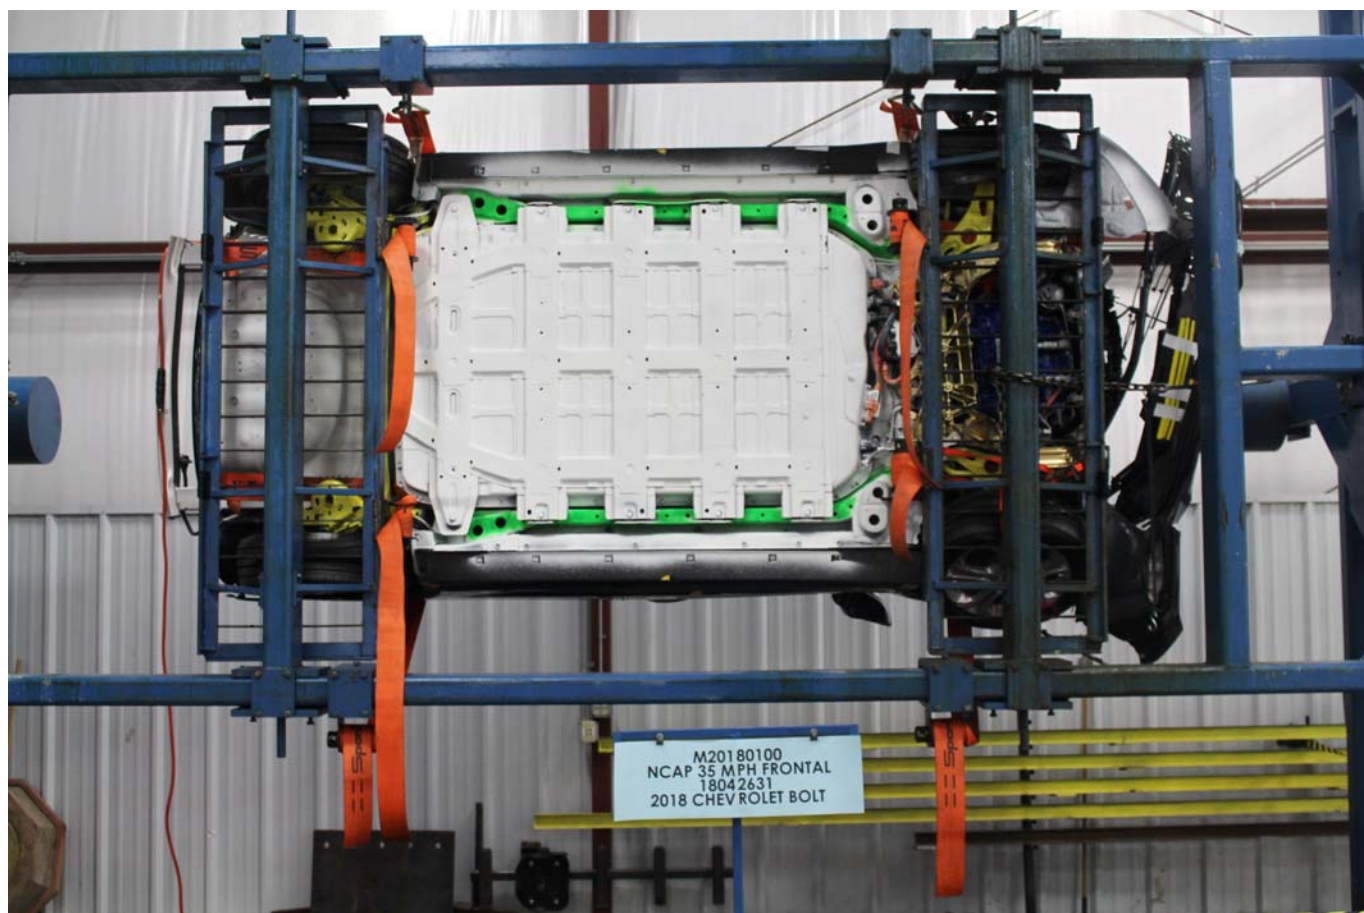
Photo No. 027 - FMVSS No. 305 Static Rollover at 90°

Rollover Stage	Electric Energy Storage/Conversion Device Electrolyte Spillage (L)	Spillage Location
0° to 90°	0	Not Applicable
90° to 180°	0	Not Applicable
180° to 270°	0	Not Applicable
270° to 360°	0	Not Applicable

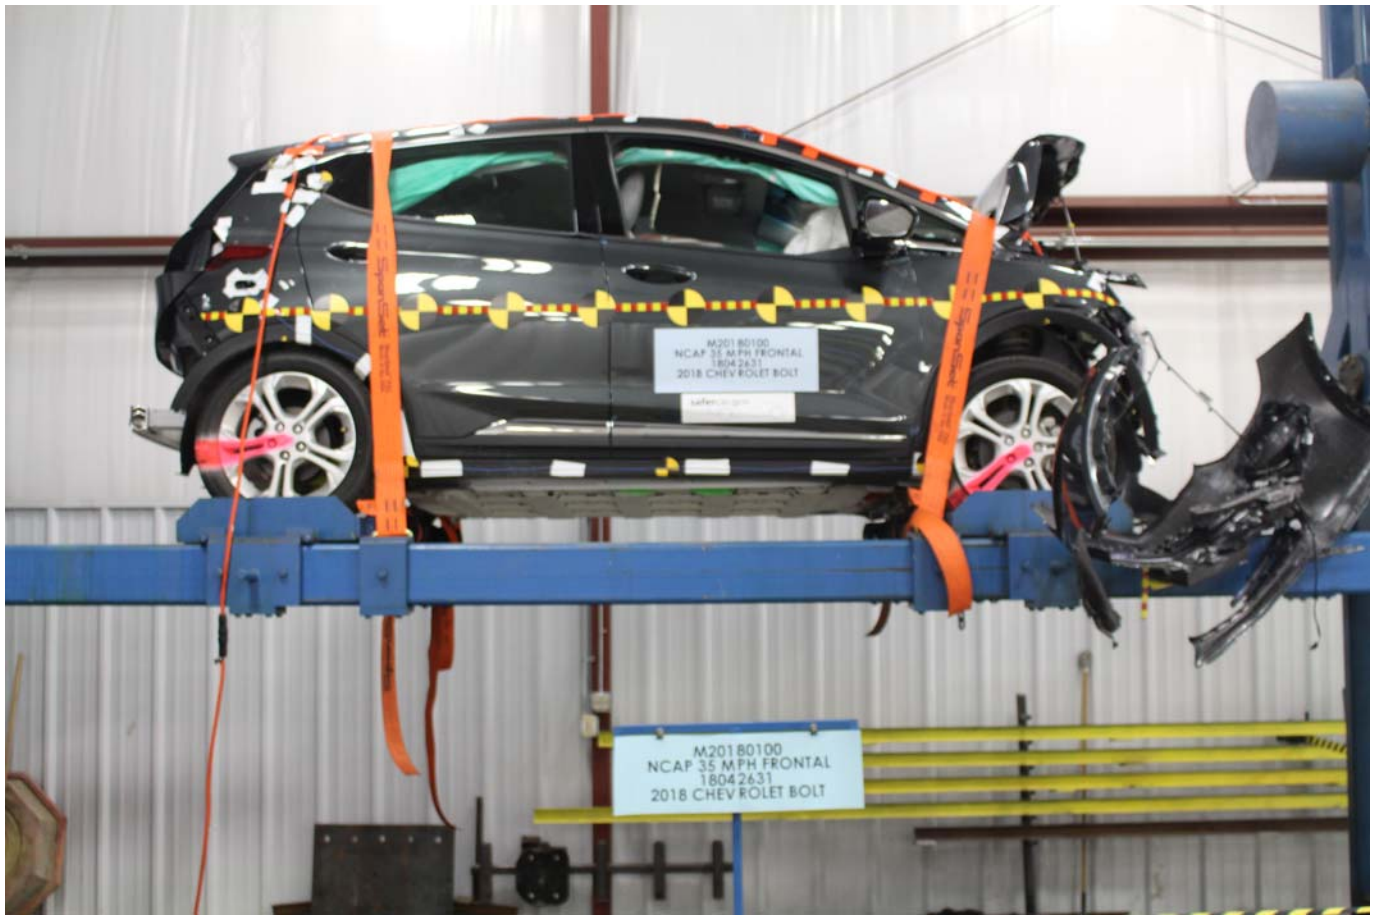
Photo No. 030 - FMVSS No. 305 Static Rollover at 360°

Total Spillage: 0 L

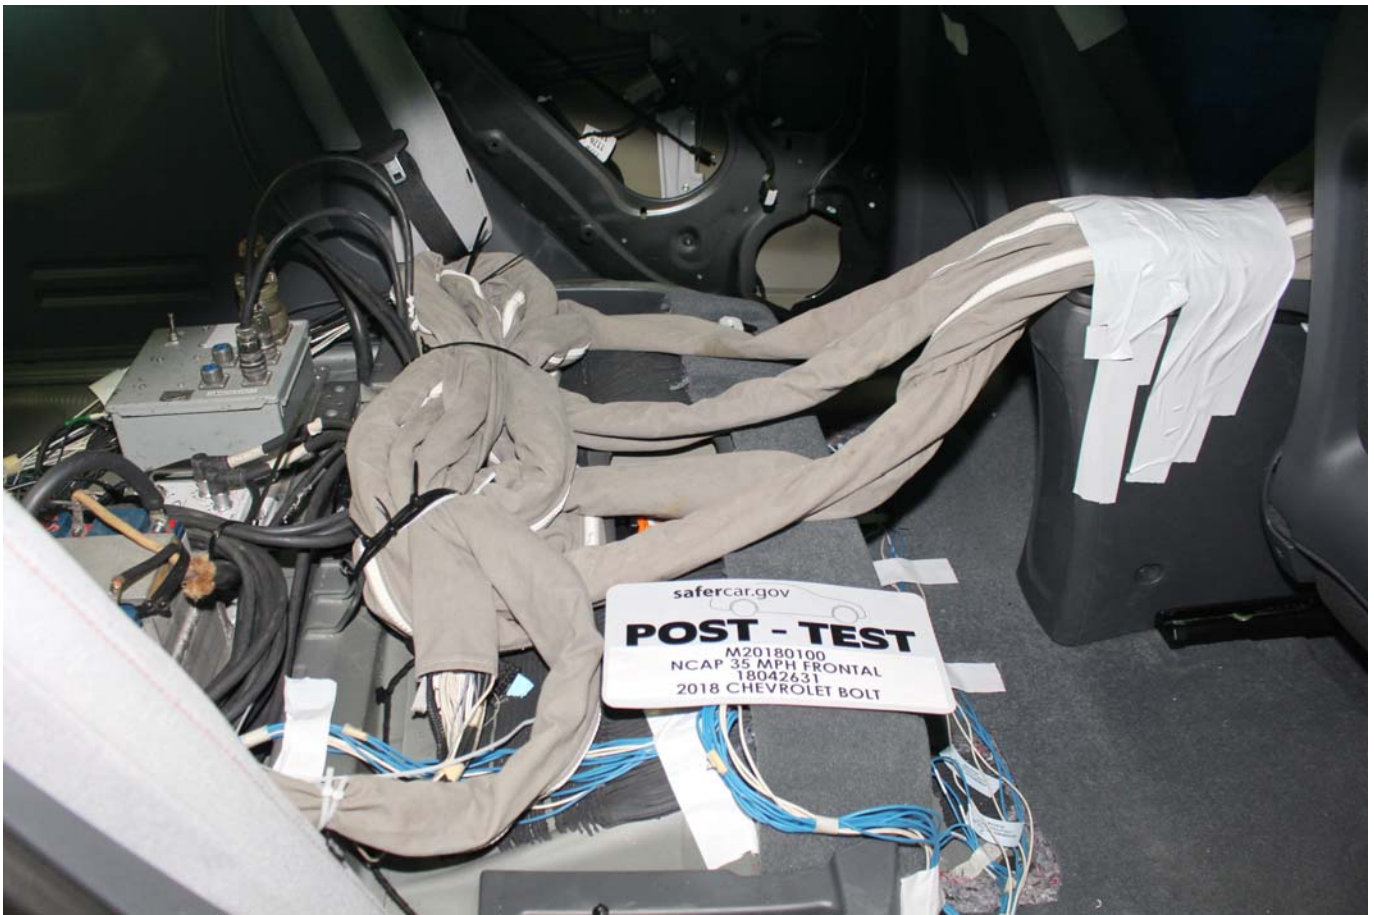
Photo No. 032 - Post-Impact View of the Vehicle Passenger Compartment Adjacent to Propulsion Battery

Describe intrusion of an outside Electric Energy Storage/Conversion Device into the passenger compartment [Supply photographs as appropriate]:
No Intrusion

Yes, Fail	No, Pass
Is Electric Energy Storage/Conversion Device electrolyte spillage visible in the passenger compartment?		X

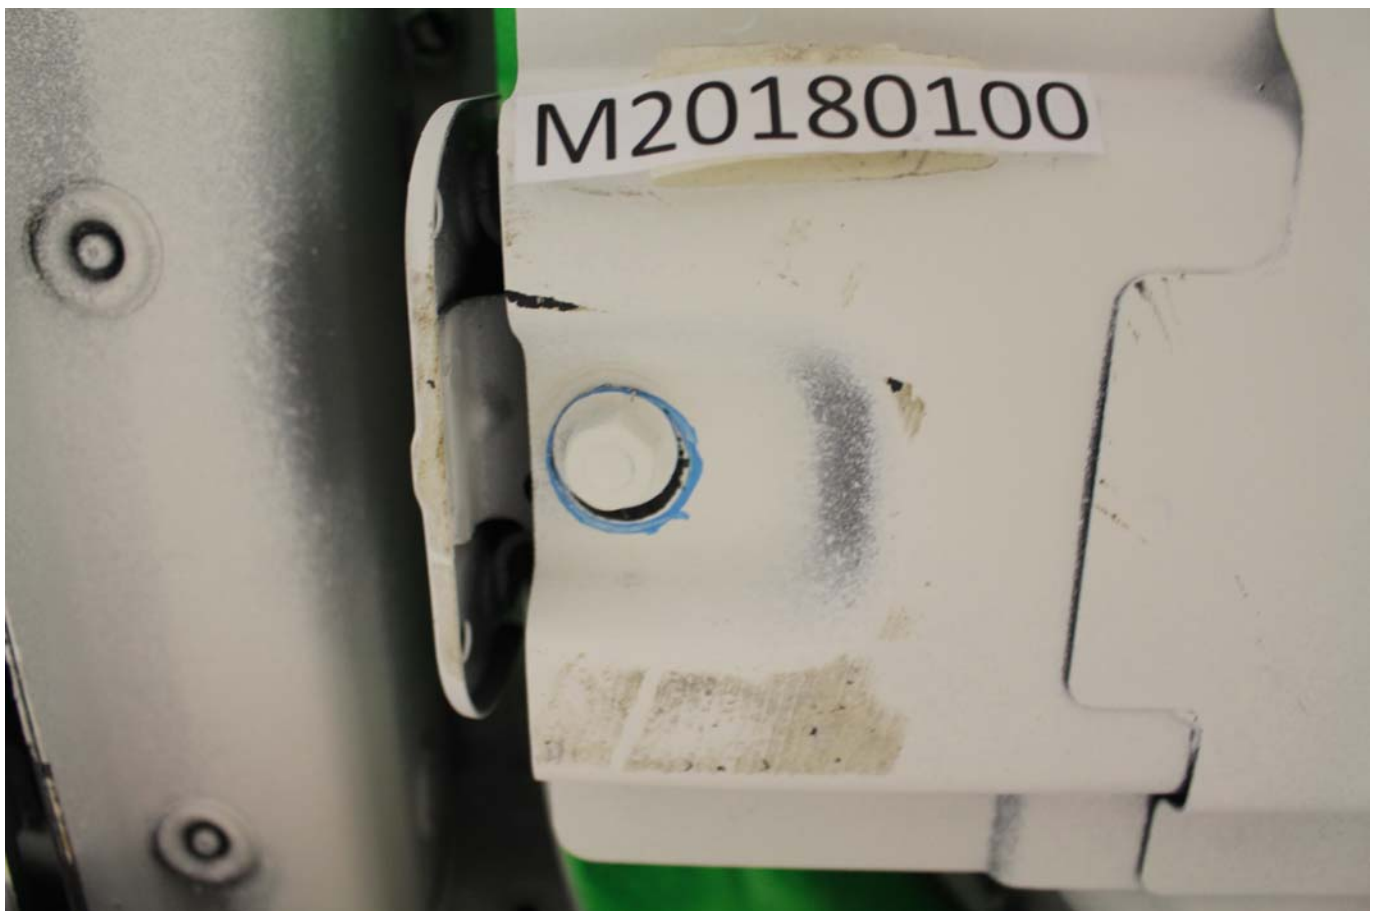
Photo No. 035 - Post-Impact View of Battery Module Movement or Retention Loss

Yes, Pass	No, Fail
All Components of Electrical Energy Storage/Conversion Device remained attached to the vehicle with at least one mounting location.	X
