Inspecting and Repairing Bolt EV Selfseal Tires

Missing Personalization Settings Menu Items

Oil Filter Installation on the 3.6L V6 Engine (LGZ)

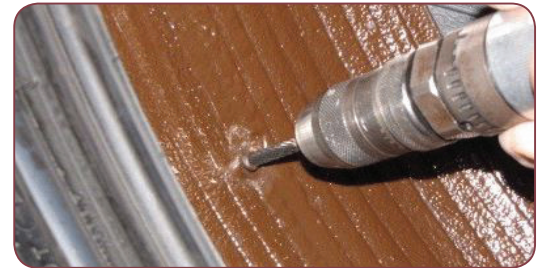
In some cases, if a Selfseal tire has a puncture that is larger than 1/4-inch (6 mm) in the tread area, the tire may not self-seal and a one-piece patch/stem unit may be needed to repair the tire. Follow the repair material manufacturer's instructions.

Bore a hole from the inside of the tire.

Selfseal tire.
To make the repair, first bore a hole (a carbide cutter is recommended) from the inside of the tire following the trajectory of the puncture.

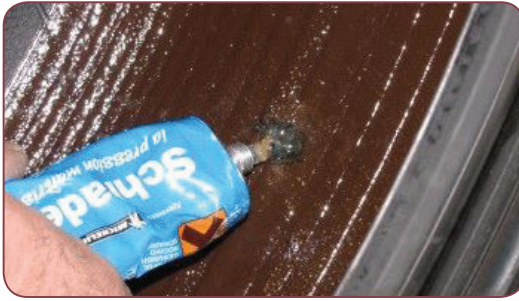
Spread the adhesive directly over the hole without brushing.

Next, spread the adhesive directly over the hole without brushing. Do not mix products from different repair material manufacturers.

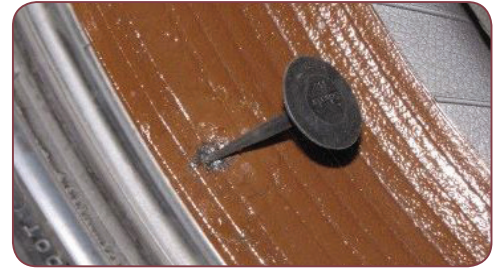
Insert the stem in the puncture.

Once the adhesive has dried for five minutes, remove the protective covering from the one-piece stem (do not touch the uncovered surface) and insert the stem in the puncture from inside the tire. Pull the stem smoothly from outside the tire.

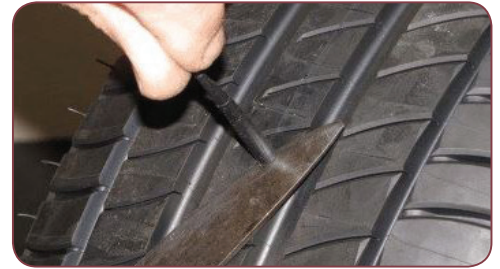
Cut the stem.

Roll over the base of the stem on the inside from the center of the stem to the edge. Cut the protruding part of the stem on the outside of the tire without pulling on the body of the stem.

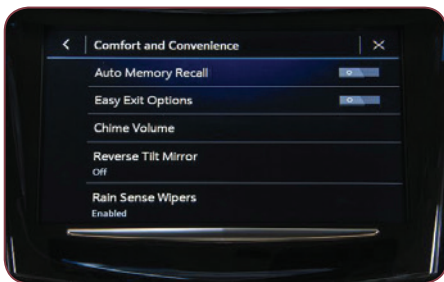
Comfort and Convenience Settings menu example

The missing Comfort and Convenience menu items may not appear when the vehicle is started and will not reappear for the entire ignition cycle. However, if the ignition is turned off briefly and on again before the radio/tuner has a chance to go to sleep, the menu items will typically reappear. The missing menu items are a result of a timing issue

between the Memory Seat Module and the radio/tuner when the key is turned on.

If this condition is found with items missing at times from the Comfort and Convenience menu, reprogram the Memory Seat Module with the latest TIS2Web calibrations. If menu items are always missing from a Settings menu and never reappear over a short key cycle, or if any related DTCs are stored, follow the diagnostic procedures in the Service Information.

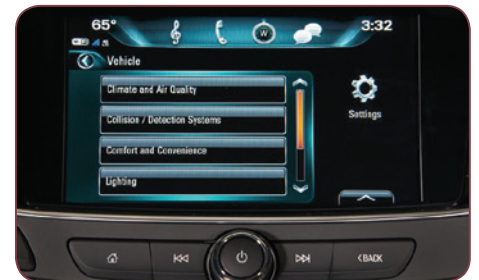
Other Vehicle Settings menus

Just as with the Comfort and Convenience menu items, these other Settings menu items may not appear when the vehicle is started and will not reappear for the entire ignition cycle, but may reappear if the ignition is turned off briefly and on again before the radio/tuner has a chance to go to sleep. In addition, when selecting the climate control settings, the HVAC system will respond correctly but the selections will not be displayed on the bottom of the infotainment screen.

Sierra and Yukon models equipped with infotainment system RPO IO5 or IO6, the radio tuner module may need to be replaced.

When replacing the radio tuner module, refer to Radio Replacement in the appropriate Service Information.

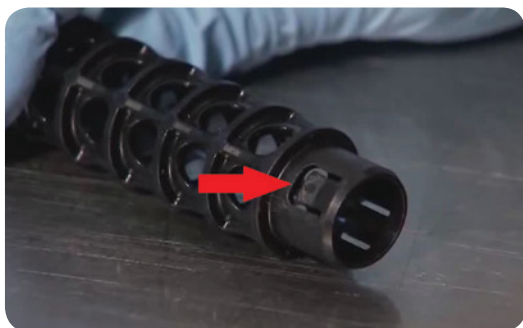
The adapter insert is retained to the oil filter adapter housing by two tabs. If the adapter insert is inadvertently removed along with the oil filter during an oil change, the filter may collapse, leading to possible engine failure. Always ensure the adapter insert is secure in the adapter housing when changing the oil filter.

Adapter insert retaining tabs

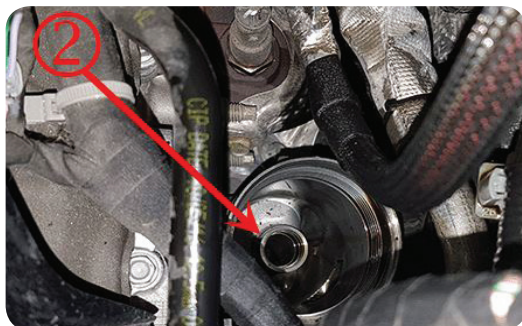
Missing oil filter adapter insert

If the oil filter adapter insert is missing, the oil filter adapter housing needs to be replaced. Currently, the adapter insert is not available as a separate part. Also check for any additional engine damage. If the engine needs to be replaced, a new oil filter adapter housing also is required in order to get a new adapter insert.
