09/2011 The failed NiMH battery backup supply for the SRAM on the earthy logic board was replaced. The charge current for the new, higher capacity battery was increased to 7mA from 0.8mA by changing R403 from 1.8kΩ to 200Ω. The RTC battery was also replaced. The boards and connectors were cleaned of corrosion marks.

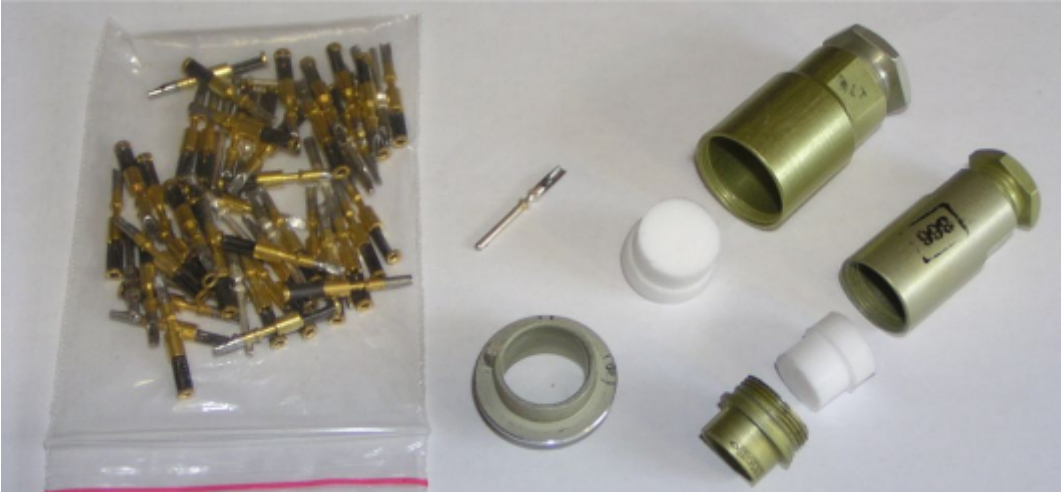
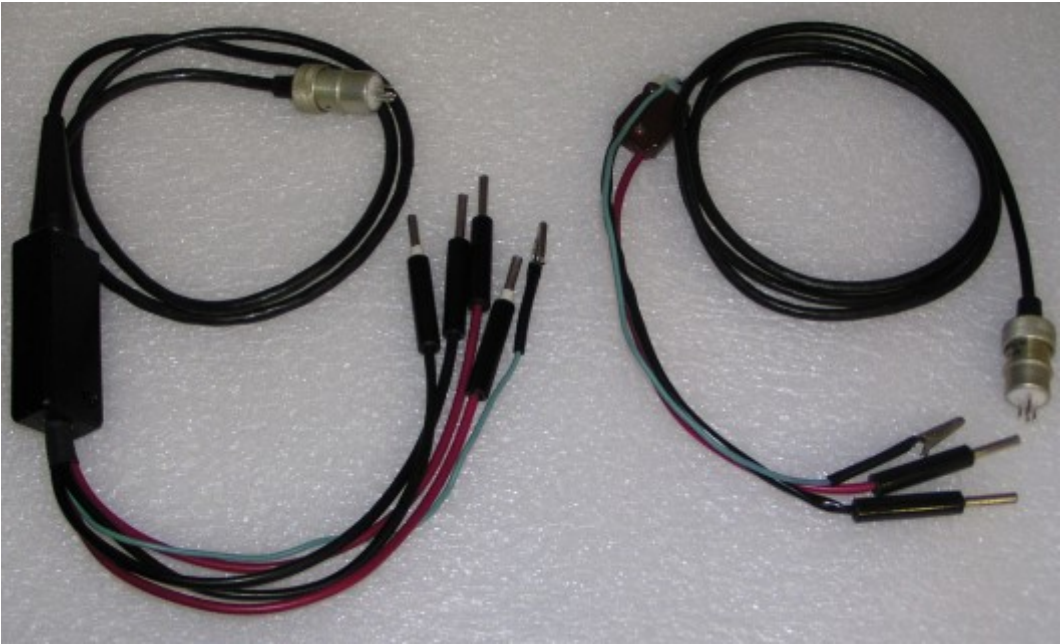
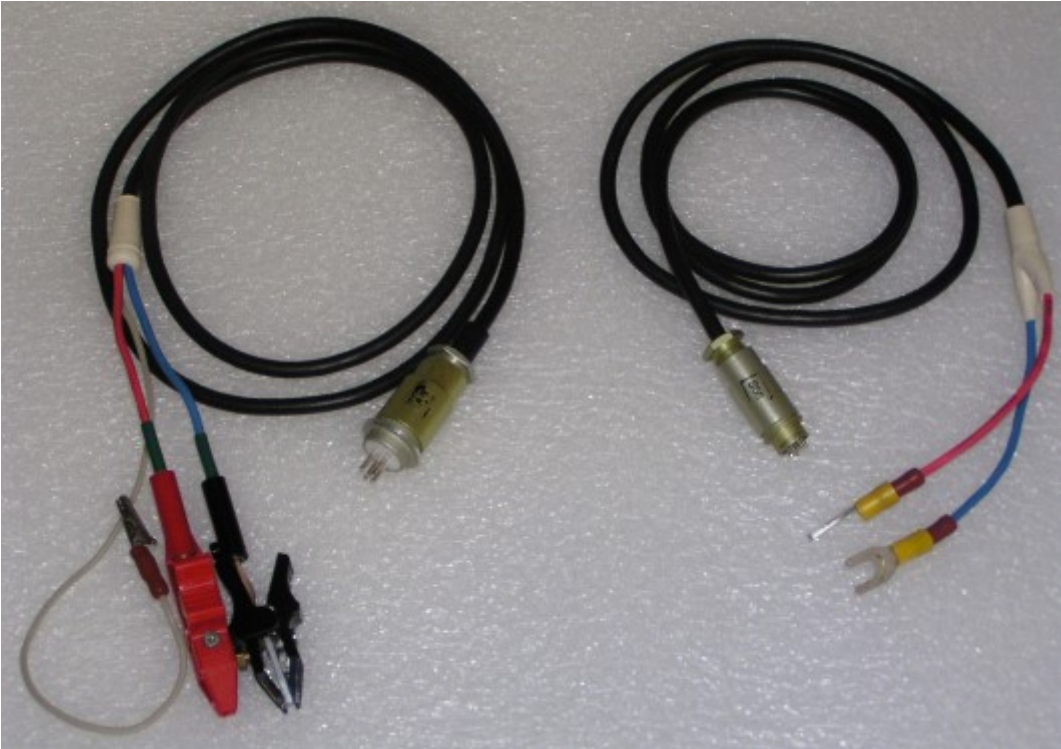
09.2011 A set of shielded cables was made.

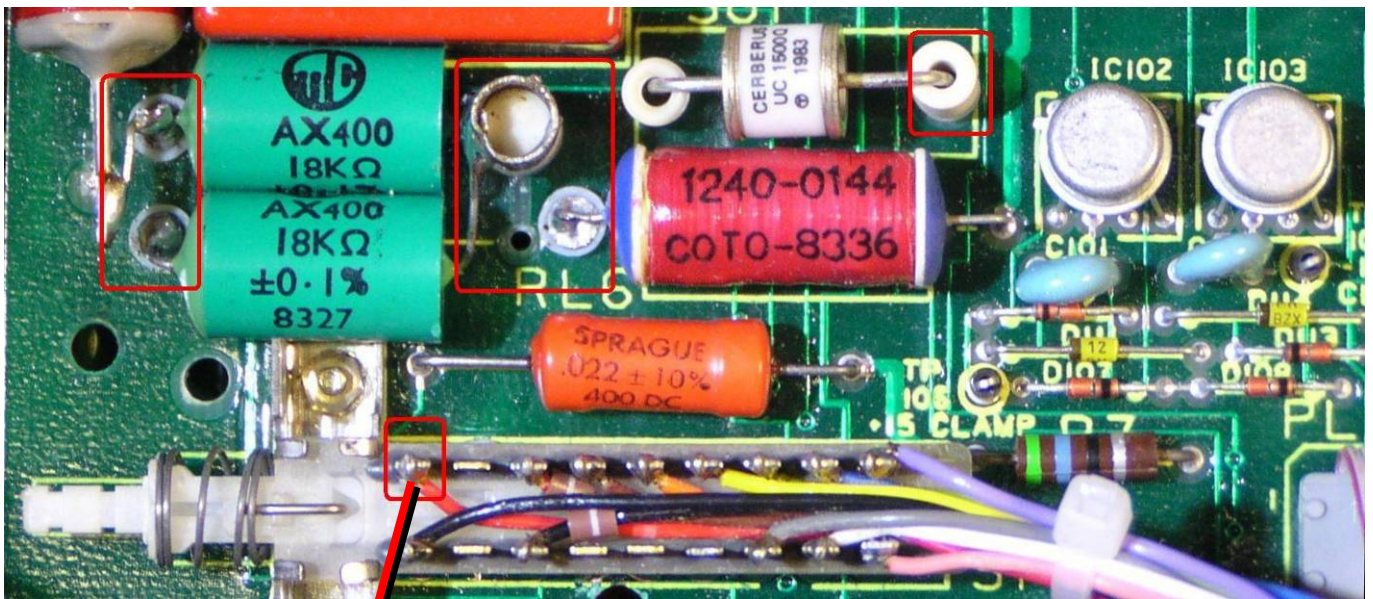
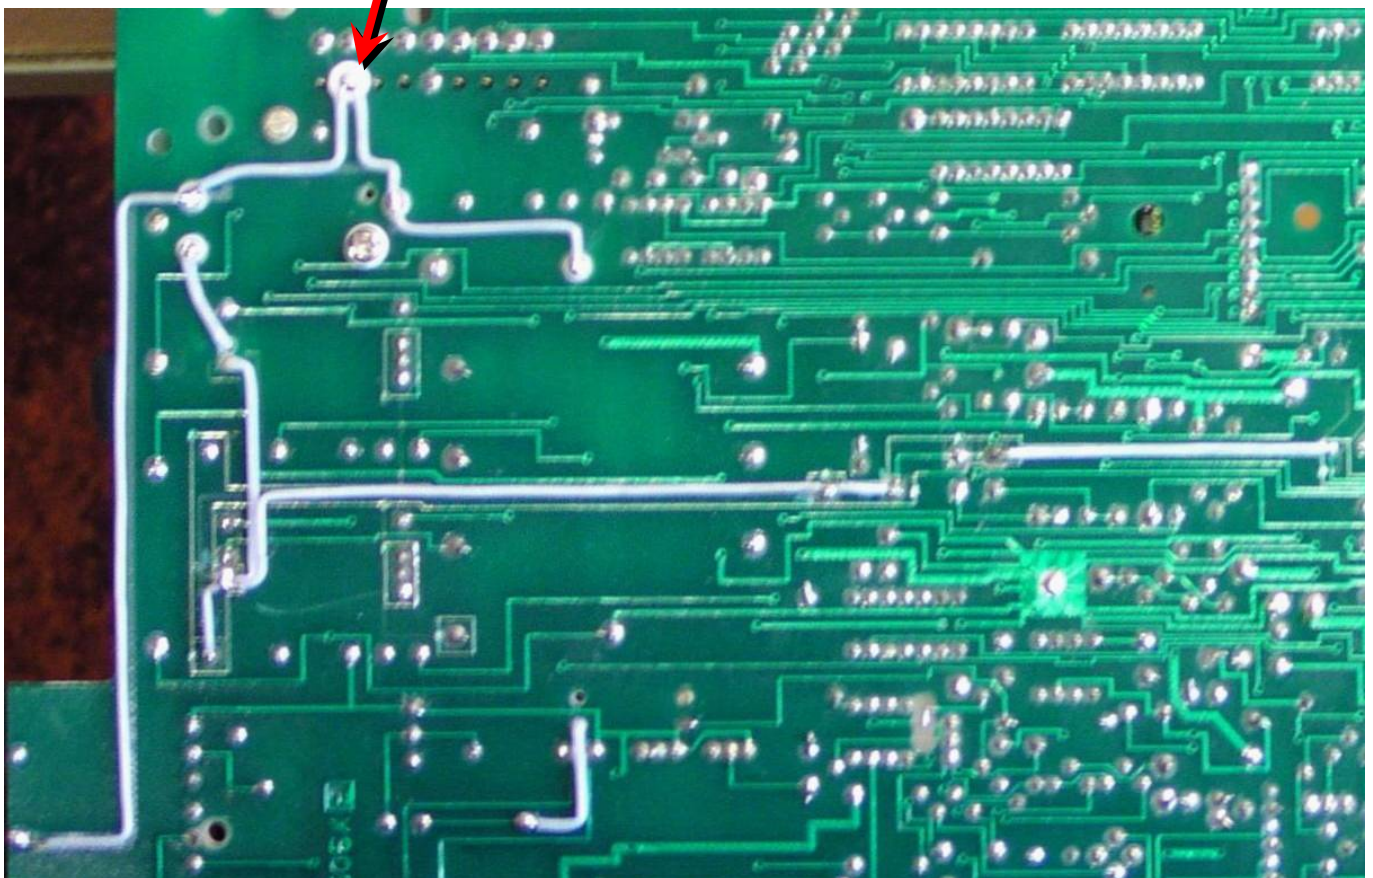
09/2011 Elements of the input circuit for the DCV channel were changed to use point to point PTFE wiring connected to PTFE pass-thru insulators to reduce the leakage current.

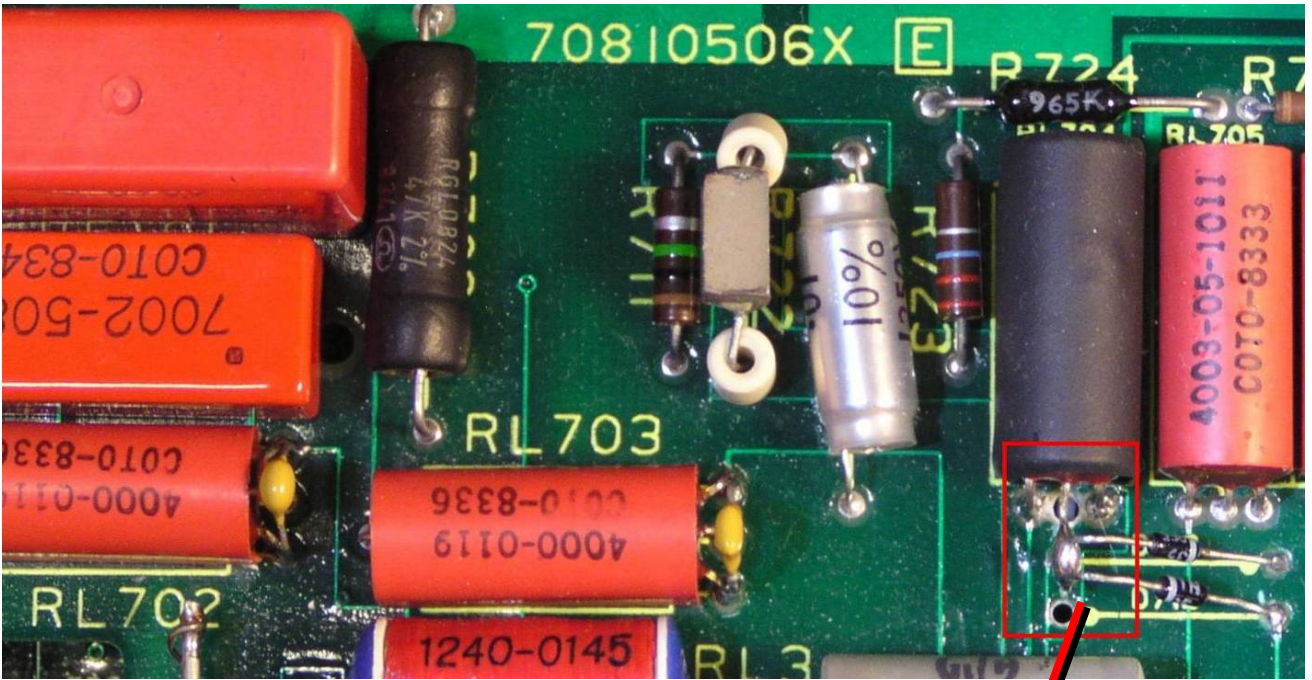
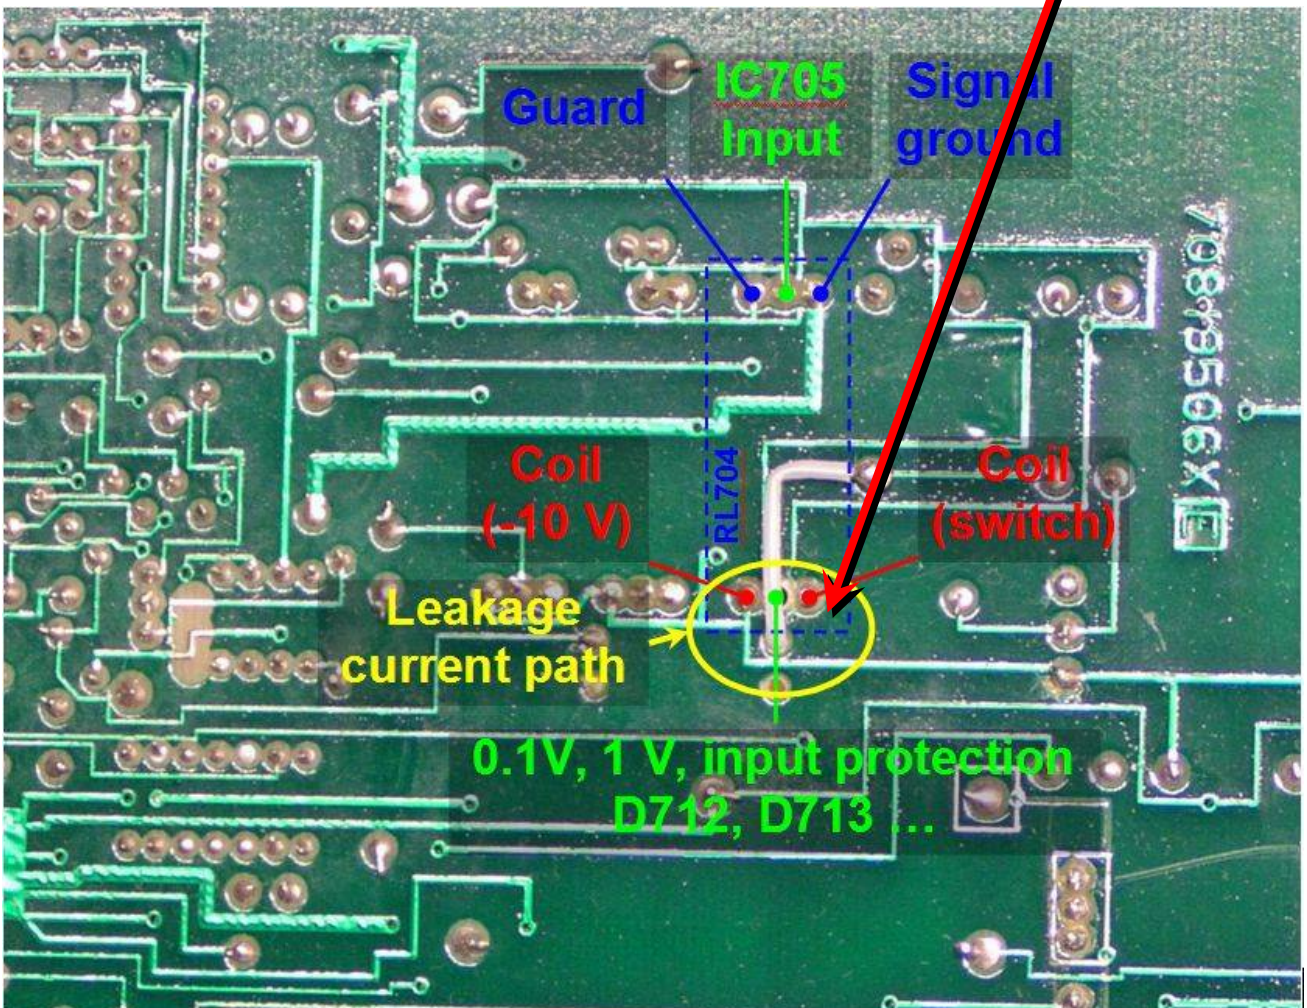
09/2011 The input high-impedance part of ACV channel circuits was partly changed to use point to point PTFE wiring connected to PTFE pass-thru insulators to reduce the zero-drift as the meter warmed up. Relay contact RL704 channel ACV was isolated from the PCB to reduce leakage and reduce zero drift. Blocking capacitors not present in this revision are added to the windings of relays RL702 and RL703.

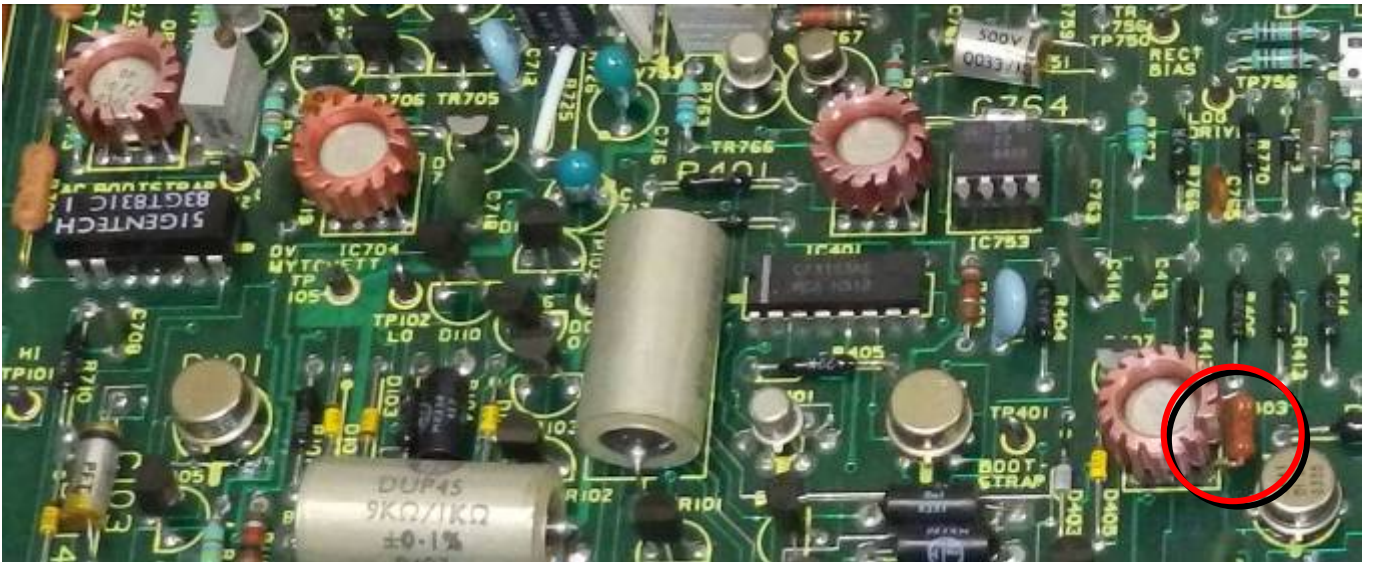
09/2011 A zero-balancing resistor was added to the IC403 Tracking Amplifier op-amp to decrease the bias voltage<sup>1</sup>. The four op-amps on the PCB 6 board were fitted with heat-sinks.

<sup>1</sup> Probably better to connect a 100kΩ trimmer between pins 1 and 5 with the wiper to pin 4, allowing adjustable zero offset compensation.

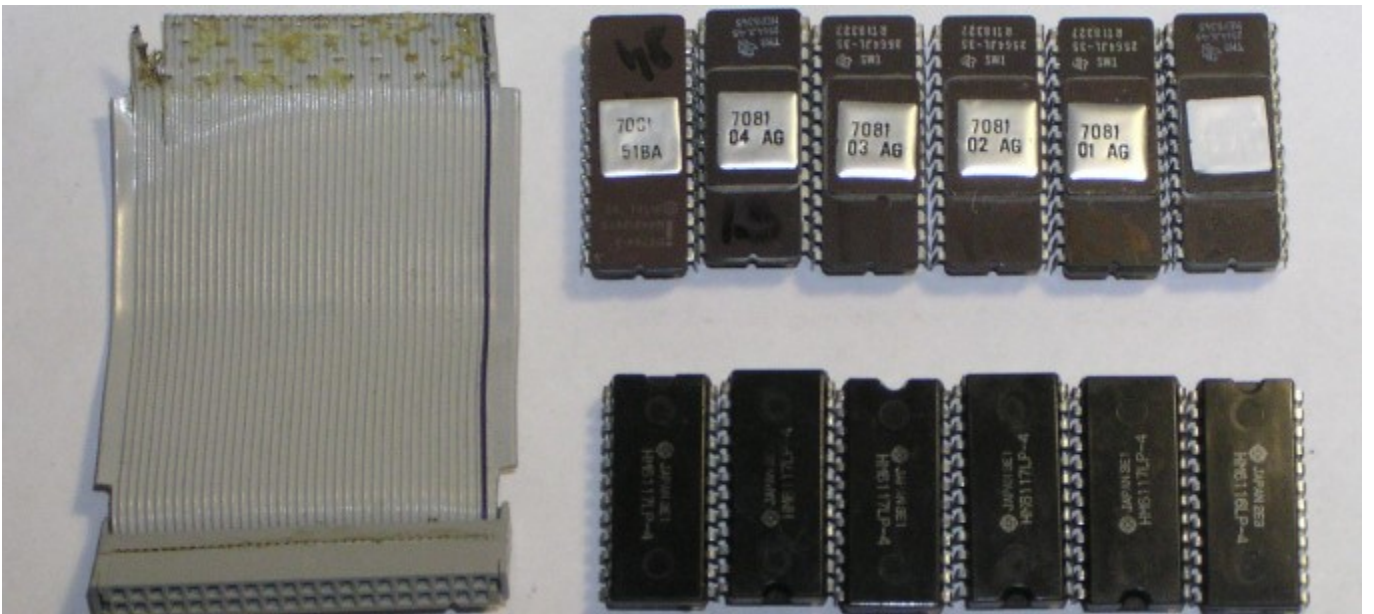
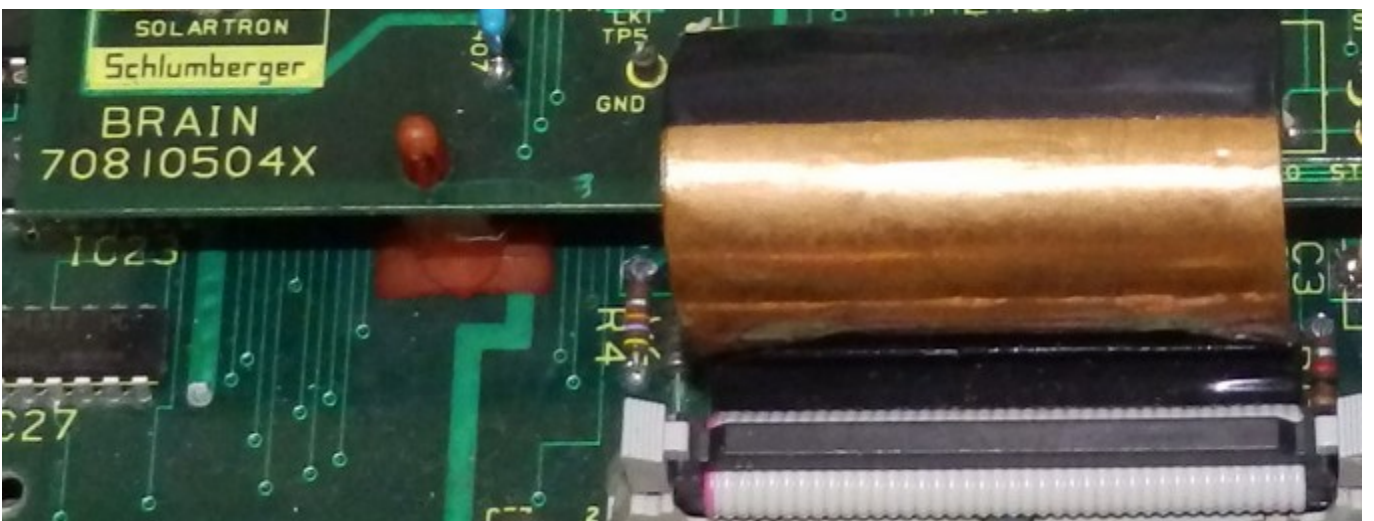
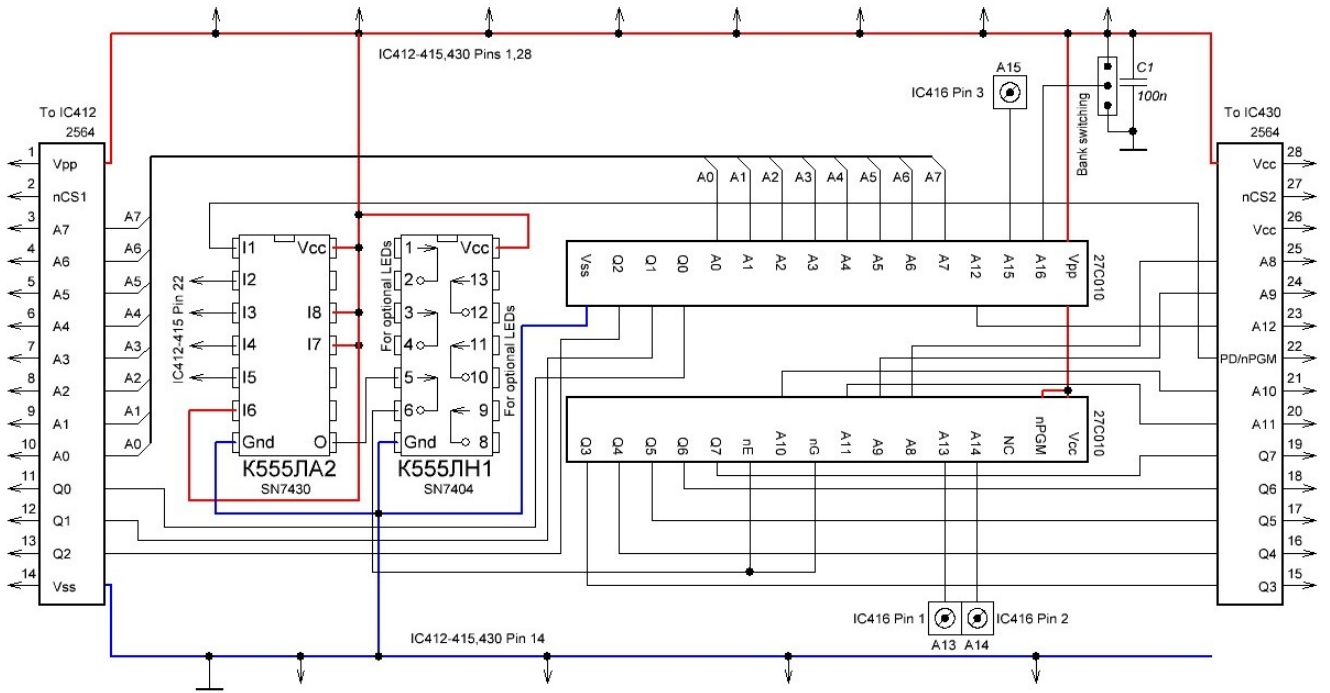
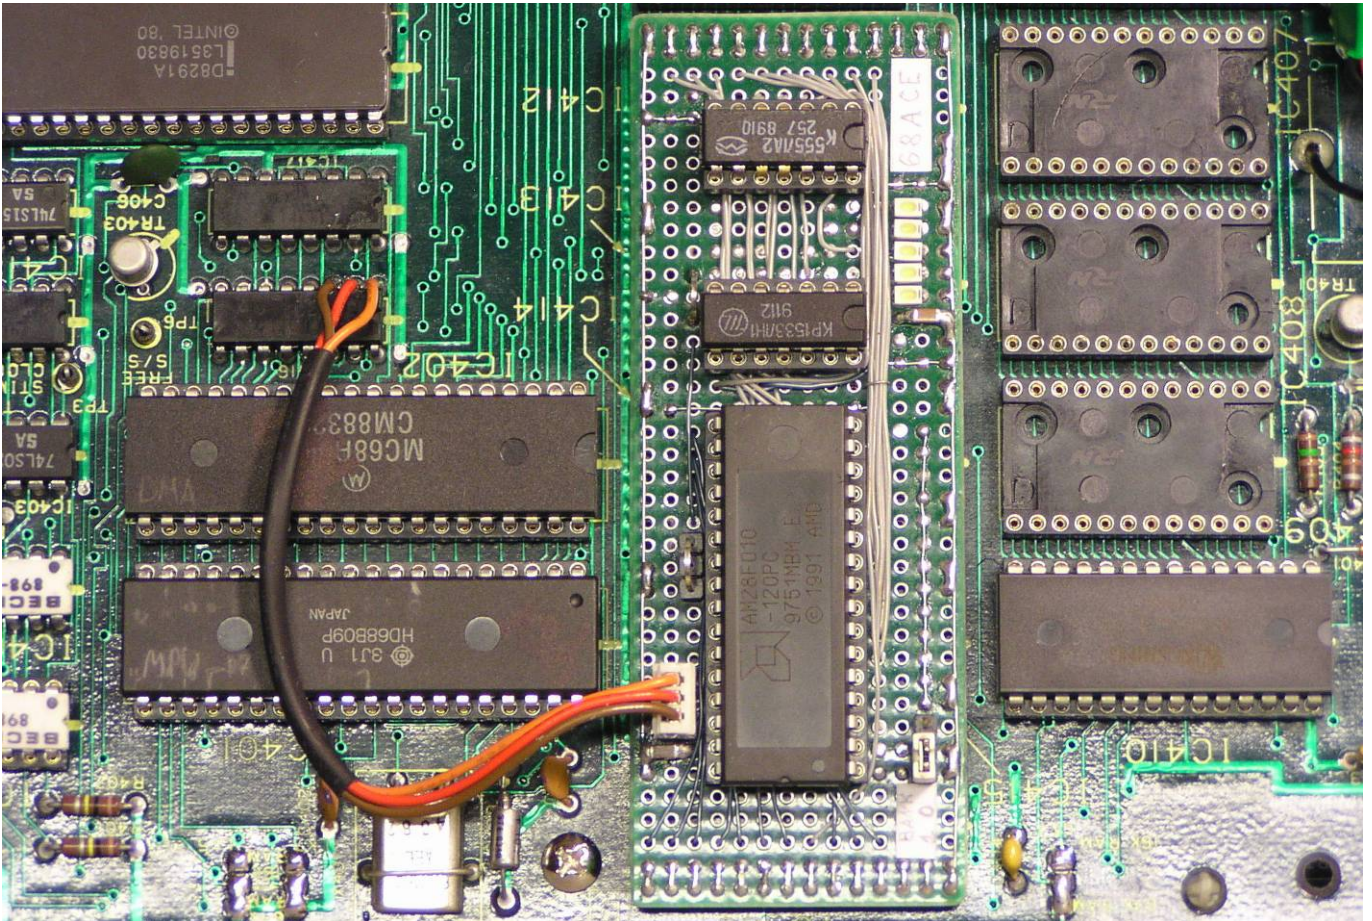
**11/2011** The faulty ribbon cable to the Earthy Processor board was replaced with a home-made shielded cable. Replaced 6 6416 SRAMs with two 6464. Instead of the 5 2764 ROM ICs I installed a 28F010 flash ROM on a mezzanine board with jumpers to allow a choice between software levels. The 2764 EPROM on the Floating Logic board was replaced with a 28C64. All firmware was updated to the latest level.

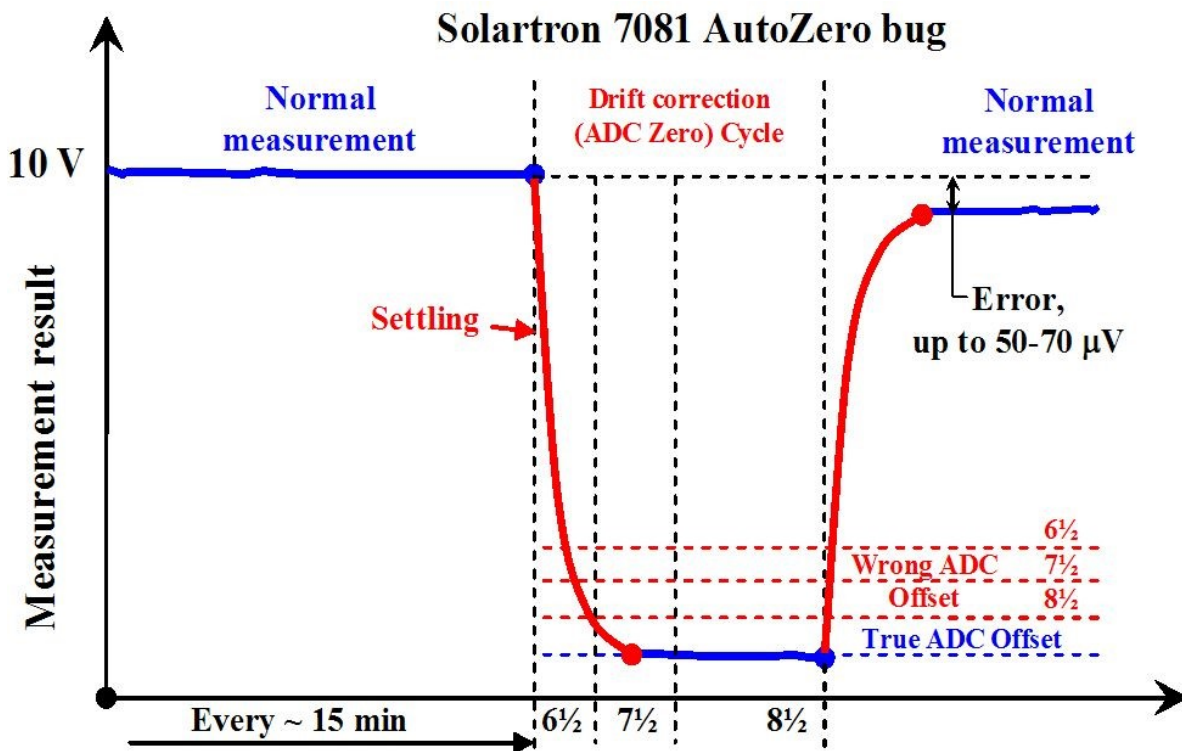
11/2011 A problem with the automatic zero offset correction was discovered which was dependent on the input voltage. This problem arises because of the finite settling time when the Auto-Zero correction logic switches the ADC multiplexer between the input signal and zero volts. To solve the problem, the software in the Floating CPU was disassembled, maps of memory allocation and I/O ports were compiled, and the algorithms of two finite automata were established. Using a logic analyser, the structure and timings of the inter-processor messaging system were determined, and the way the messages were

encoded were determined. In the Floating CPU firmware Test\_Zero\_Patch procedure was added, which provides an additional delay for the transients during the automatic zero correction of the ADC. Although the problem did not completely disappear, the zero-offset error became several times smaller

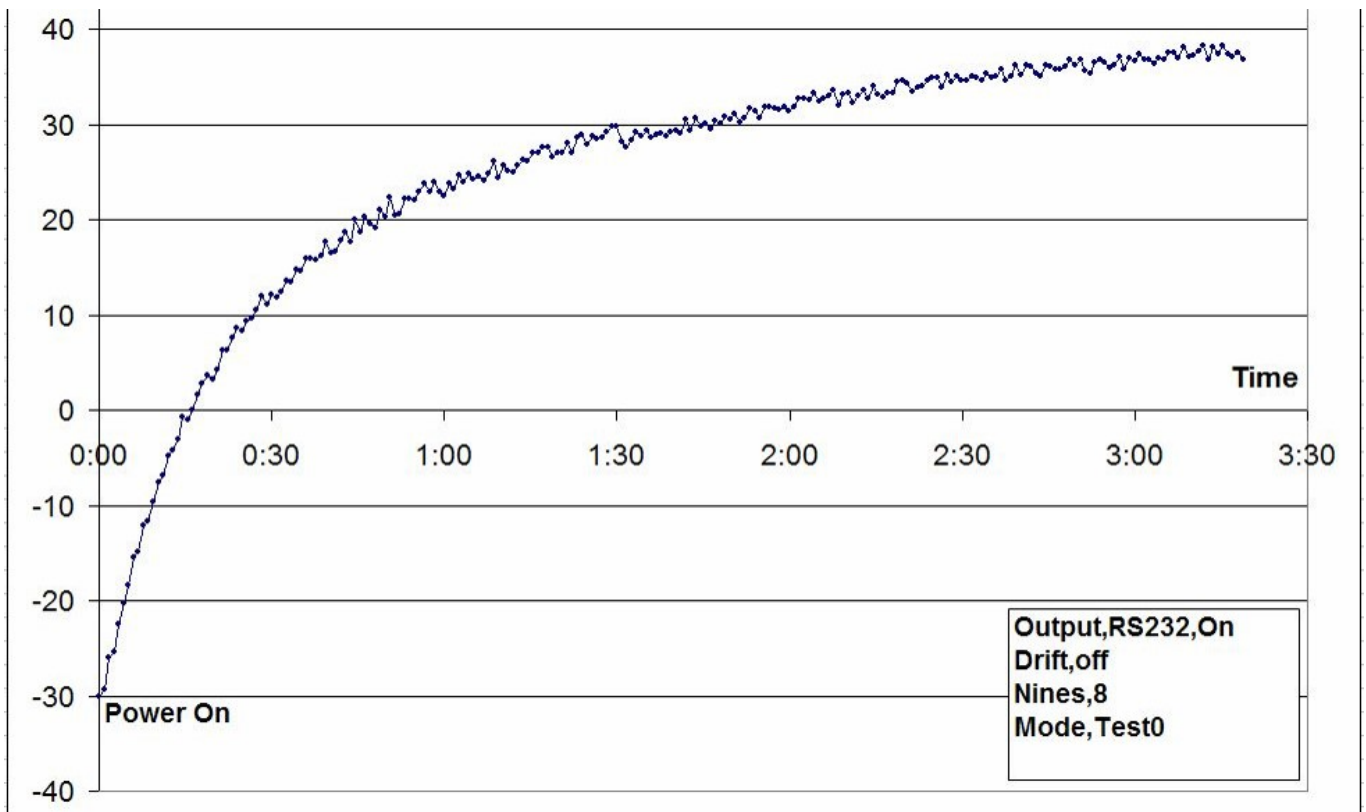
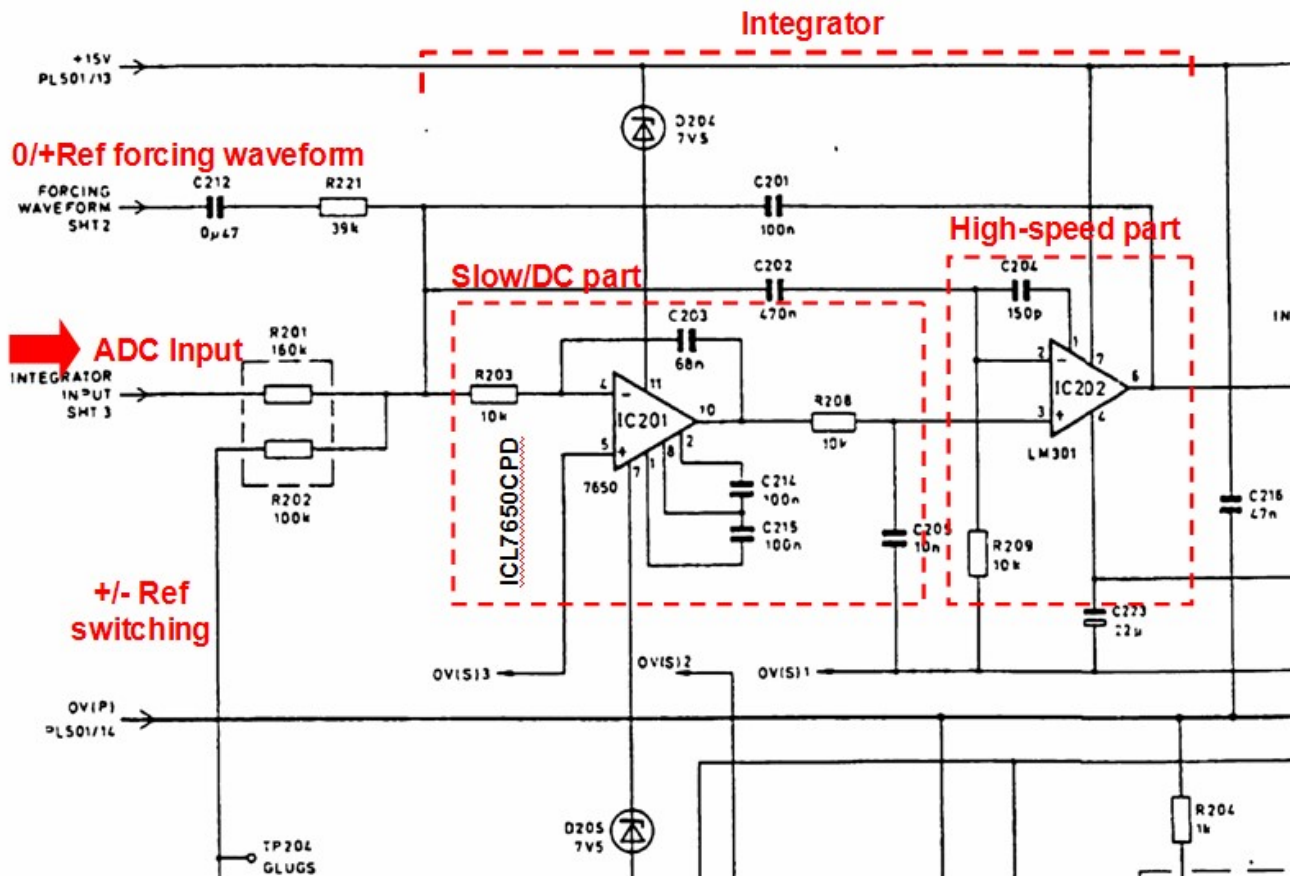
**01/2012** A problem of a large zero offset drift was found in the instrument readings as the instrument warmed up from a cold start with a shorted input to the ADC.

The search for a source of bias led to the following possible reasons:

- a) IC201 (ICL7650CPD) in the low-pass channel of the ADC integrator,
- b) Dual resistor R305 10 + 10 kOhm in the reference circuit,
- c) Op-amps IC305 and IC306 (OP07EZ) in the reference circuit, and
- d) Transistor TR302 in the negative voltage reference.

Op-amps IC305 and IC306 (OP07EZ) were replaced with OP97F in sockets. Op-amp IC201 (ICL7650CPD) was removed, and temporarily replaced with an LTC1052CN. The Zener diodes in the power circuits of Op-Amp IC201 were replaced by linear regulators LM78L08 and LM79L08 with smoothing capacitors. R305 was removed and the TCR for each half was measured. They were found to be different. This was adjusted by bifilar winding 0.99 m of 0.25 mm diameter copper (measured resistance 0.43 Ohms) over the case of R305 and connecting it in series with the lower end of R305b.

The drift was reduced by an order of magnitude.

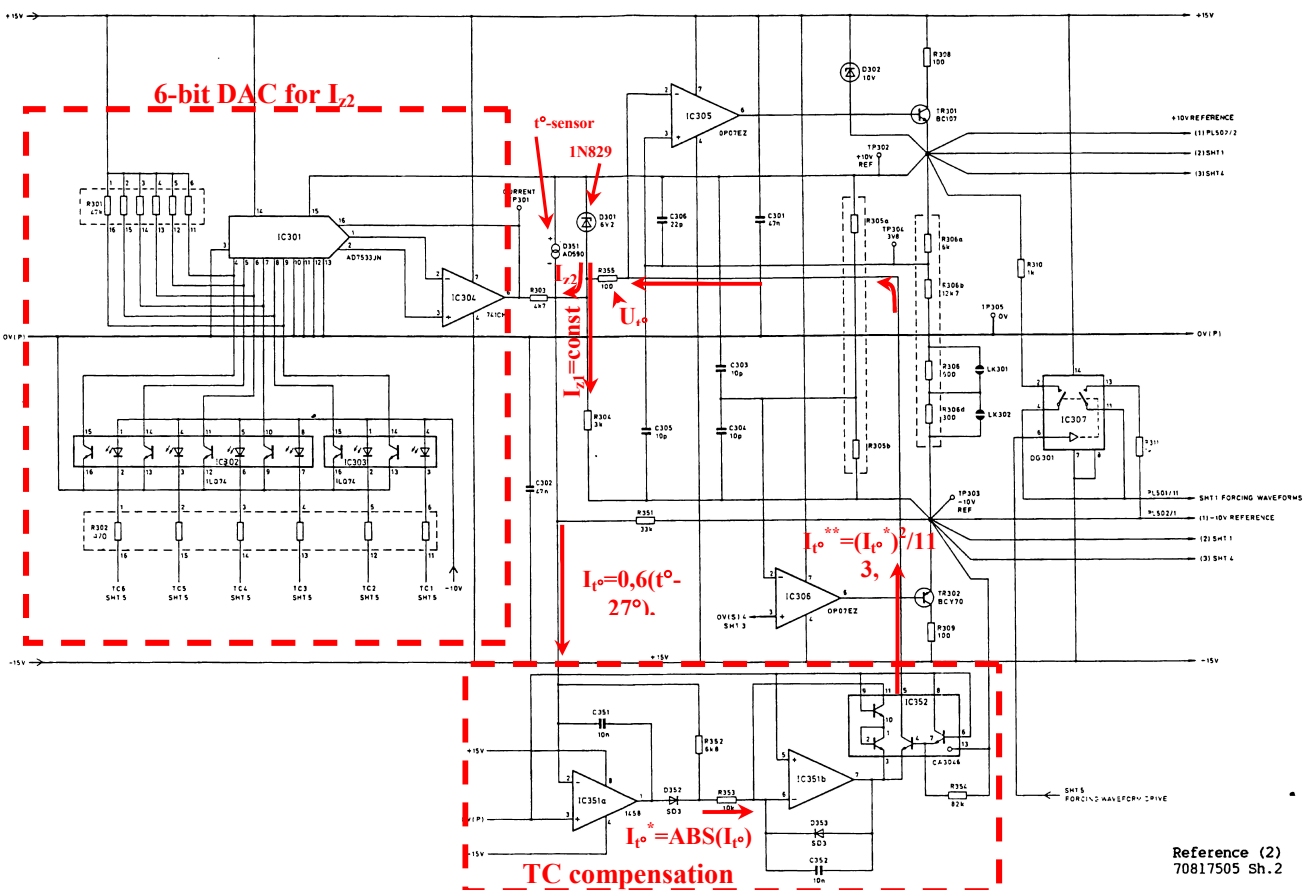
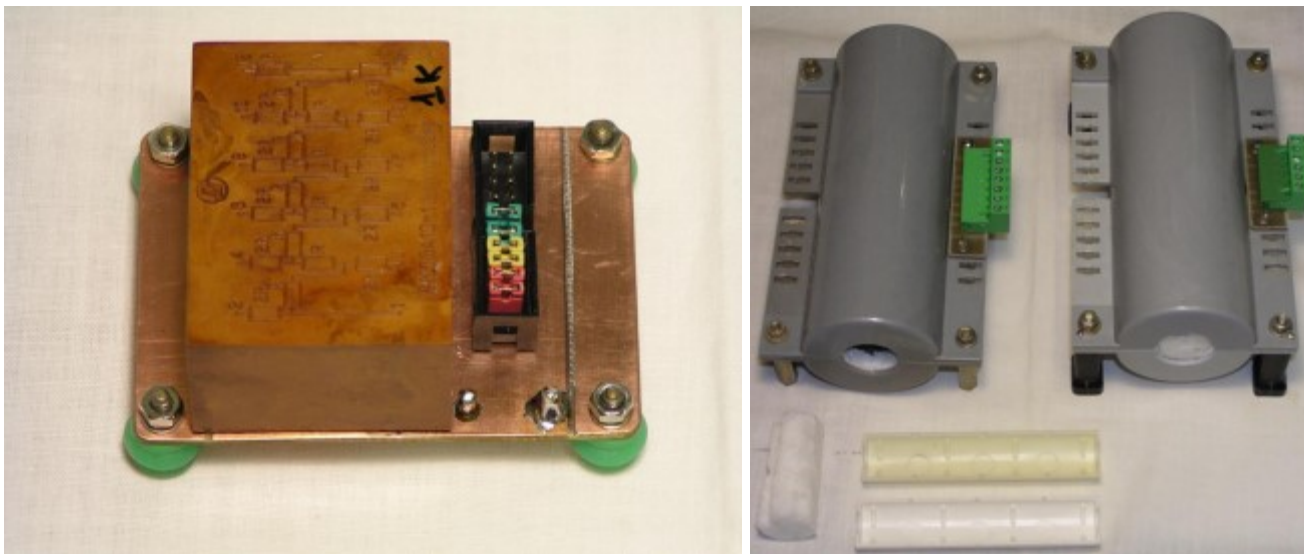
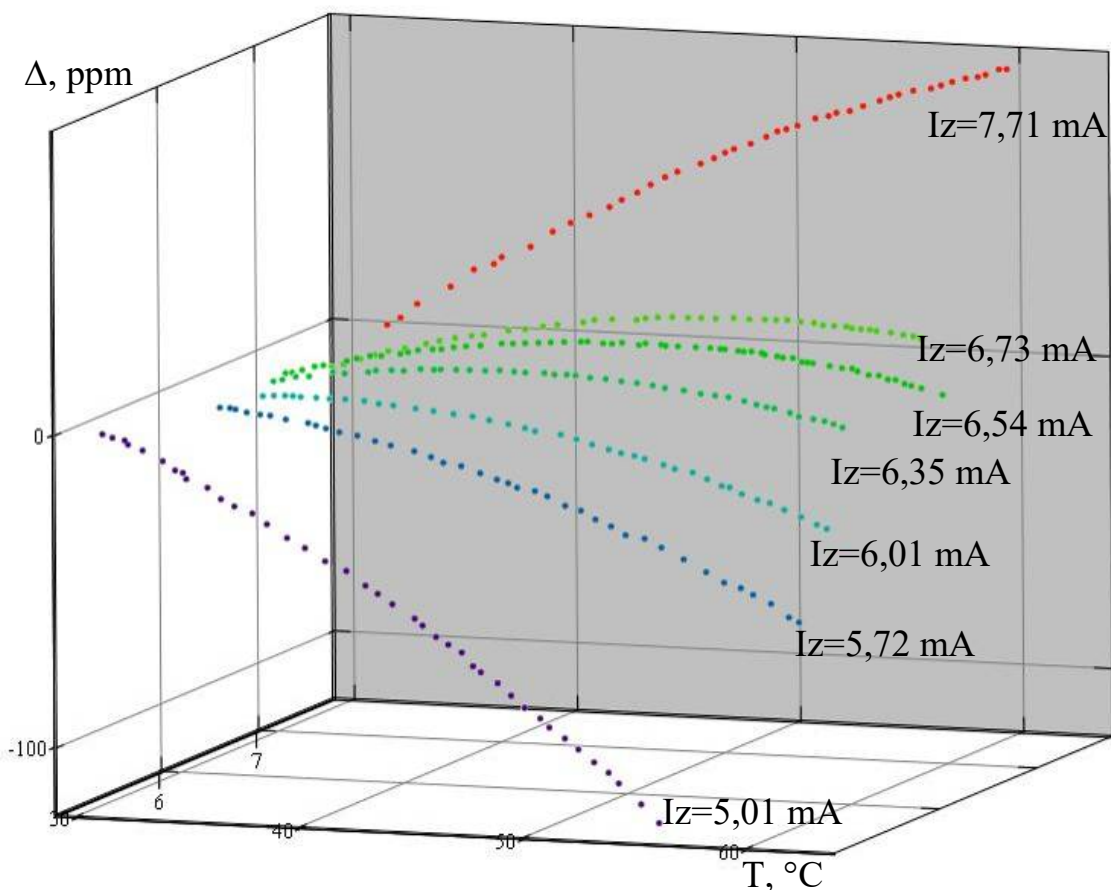
**Zener diode D301 characteristics**

02/2012 A problem with the parabolic temperature compensation of the reference Zener diode was identified

The reference Zener D301 (1N829A), temperature sensor D351 (AD590), compensation resistors R351 and R354 (which set the intercept and slope of the compensation curve) were removed. The actual resistance of the resistors R351 and R354 were measured.

An experimental setup was assembled from a thermostatically controlled oven, a 10 V reference based on an LTZ1000 and precision resistance box based on the precision wire-wound voltage divider DND5A10-1. The temperature drift of the Zener voltage of D301 was measured at various operating currents.

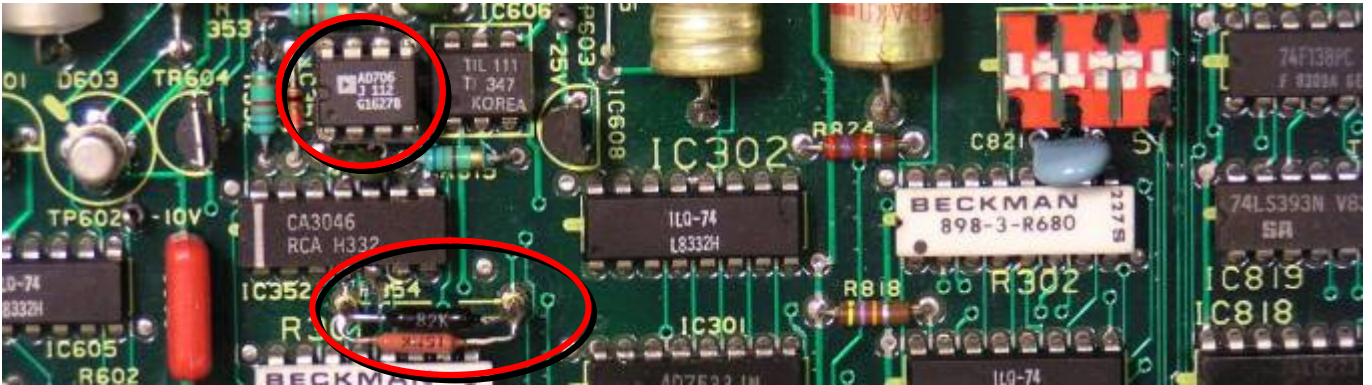
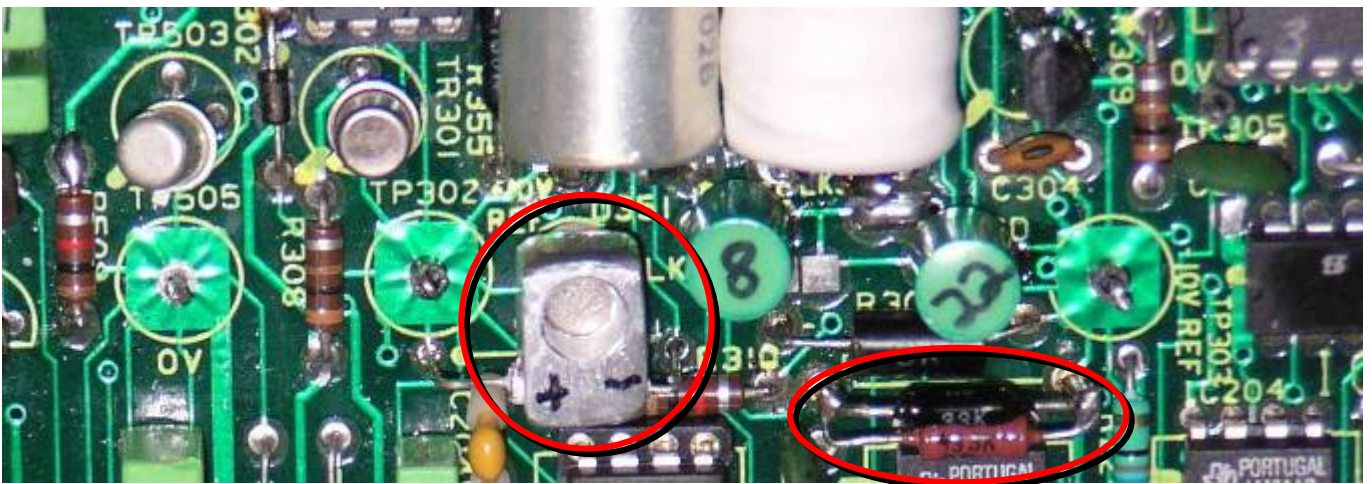
**05/2012** Zener diode working point and parabolic temperature compensation circuit parameters were reconfigured. A new DAC #102 token is assigned instead of #76, that is, the working current is established via a Zener diode  $I_z = 6.540$  mA, the Zener point of the Zener diode is shifted from 27 to 48.2 degrees Celsius. The resistances of resistors R351 and R354 were reduced to 31.11 kOhm and 81.6 kOhm, respectively, by parallel connection with additional resistors 15 M $\Omega$  and 499 k $\Omega$ .

The dual op-amp IC351 (LM1458) was replaced by a precision AD706 in the socket. An aluminium holder for both the Zener diode and temperature sensor was designed, constructed and then fitted to the diode and sensor with thermal grease.
