09/2011 The failed NiMH battery backup supply for the SRAM on the earthy logic board was replaced. The charge current for the new, higher capacity battery was increased to 7mA from 0.8mA by changing R403 from 1.8kΩ to 200Ω. The RTC battery was also replaced. The boards and connectors were cleaned of corrosion marks.

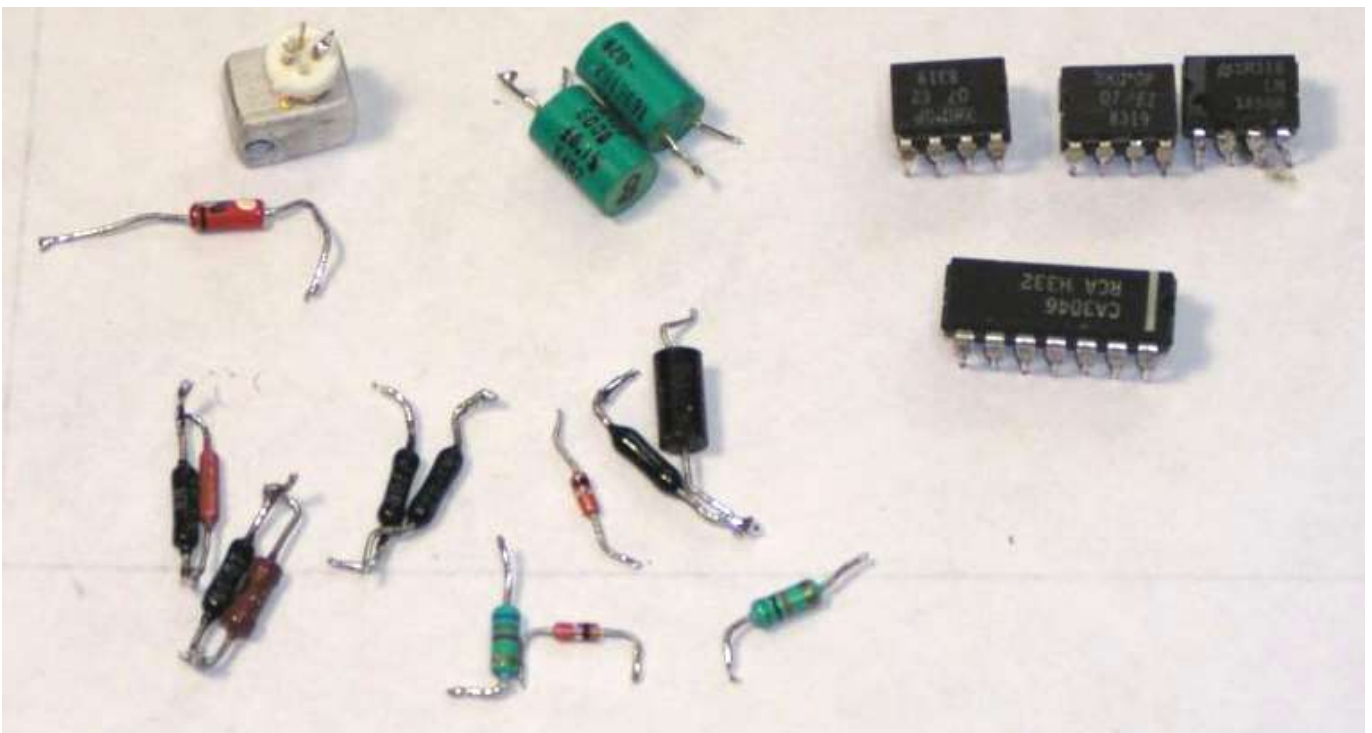
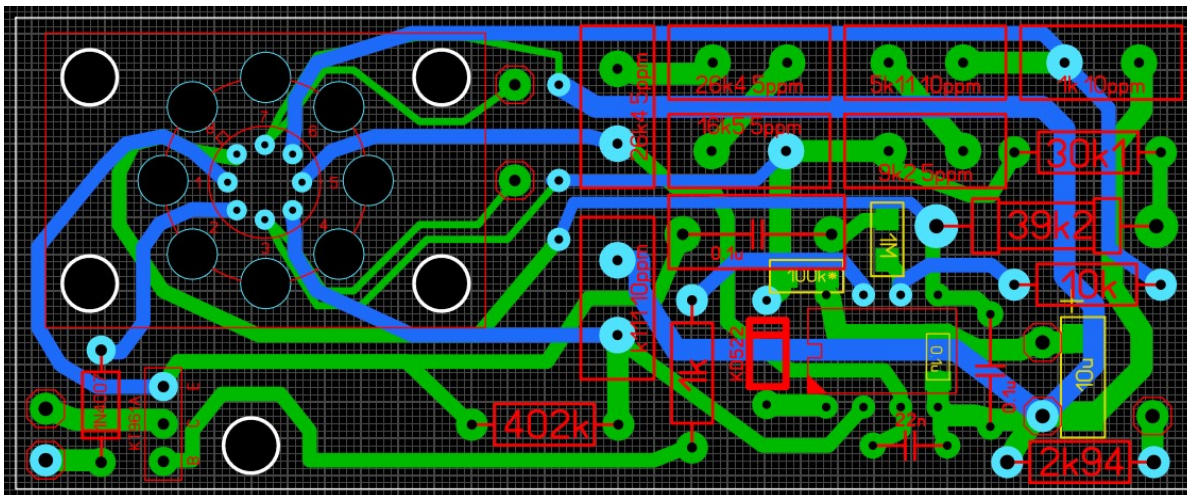
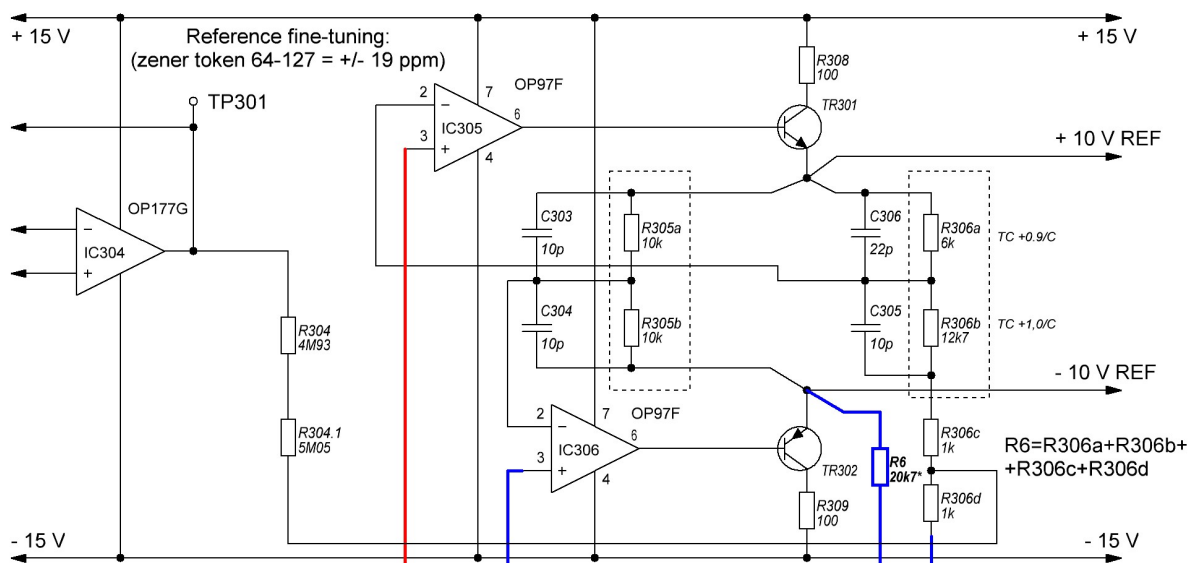
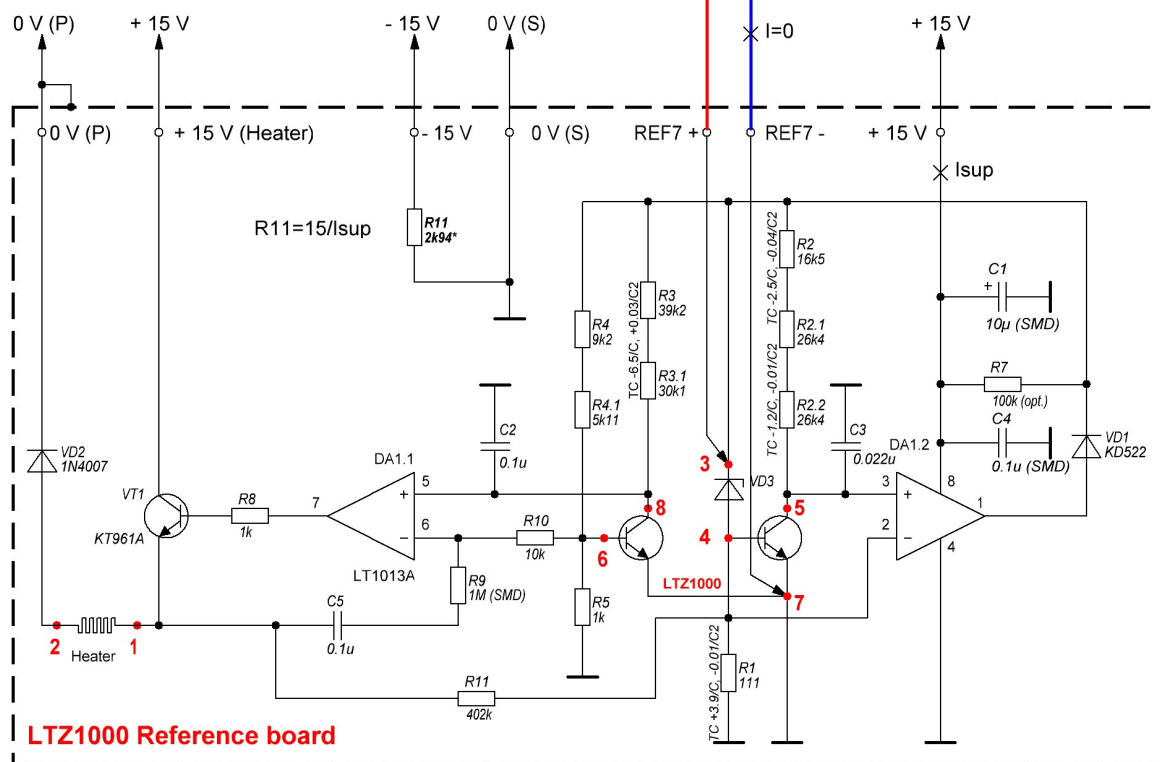
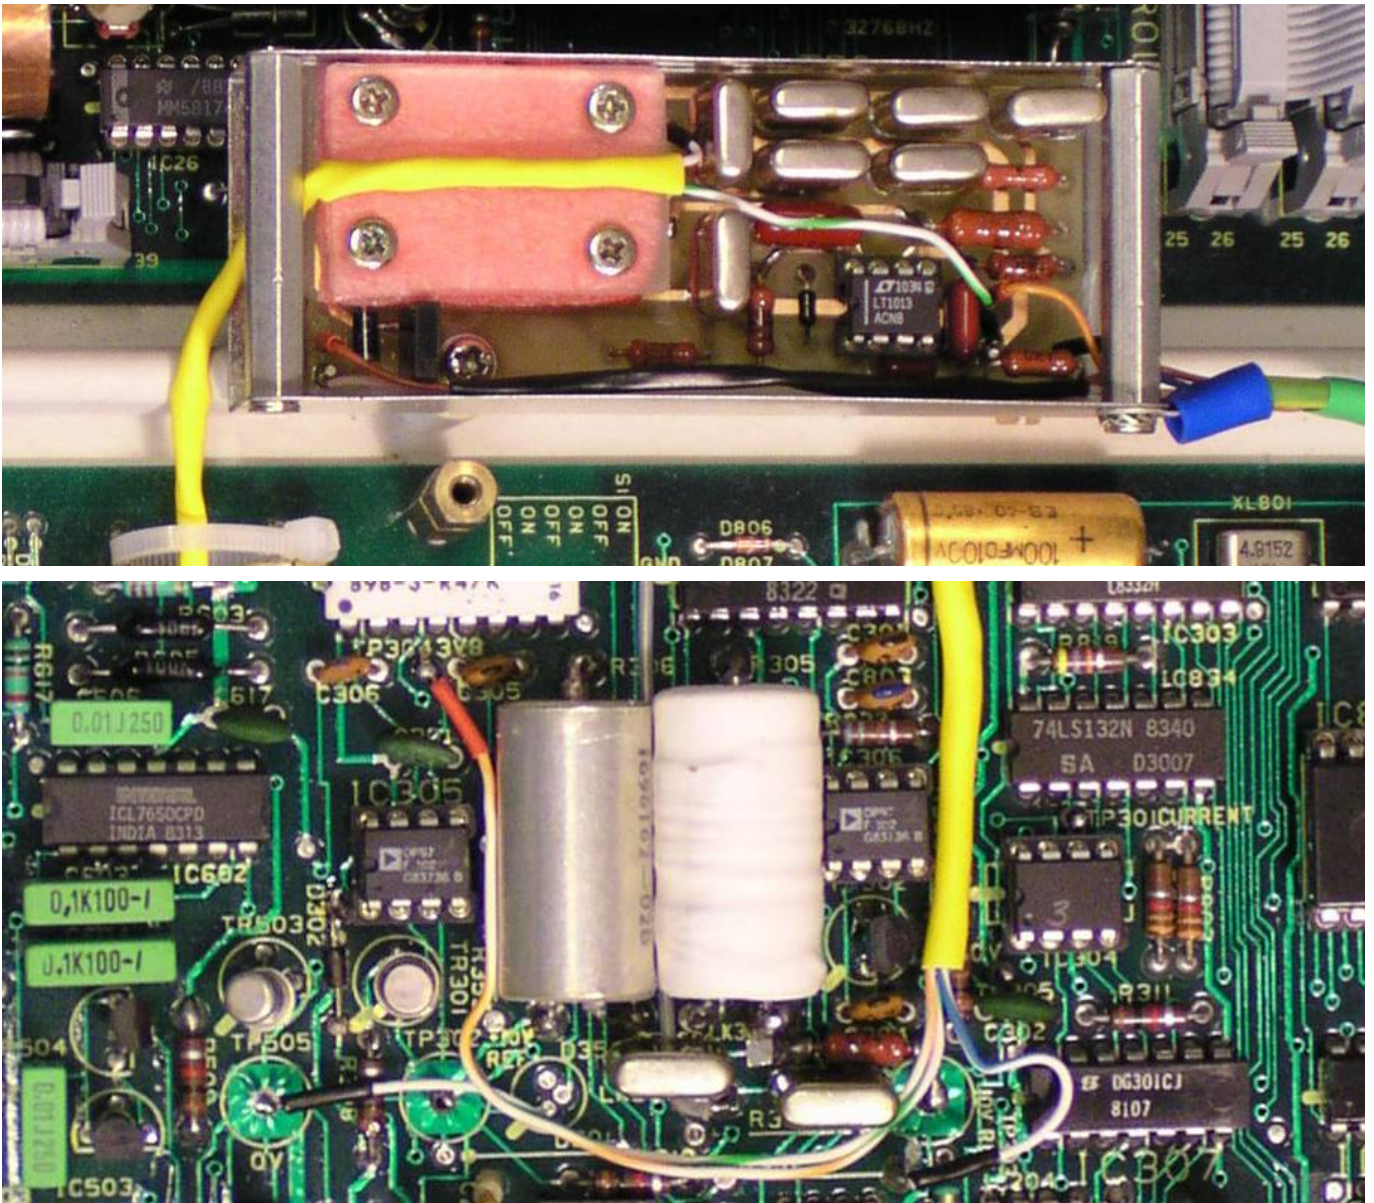
**08/2012** I decided to replace the Zener diode and parabolic node compensation with a voltage reference module based on the LTZ1000, positioned just above the mainboard.

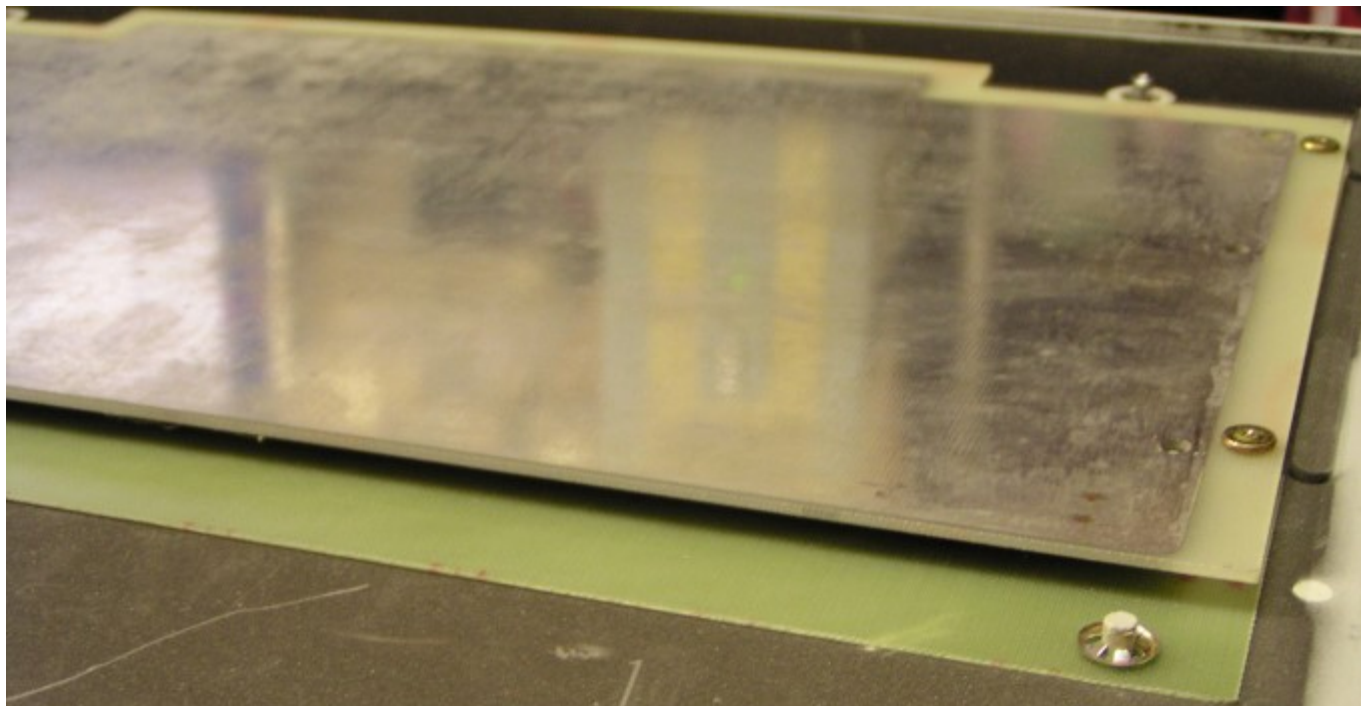
**10/2012** Plexiglas spacers were installed between the protective electrostatic screen and the upper housing cover. As a result the capacitance between the screen and grounded conductive coating decreased from 1 nF to 230 pF. The total capacitance of the parasitic structural capacitor between the grounded chassis and the isolated measuring block of the voltmeter was reduced to 1.1 nF.

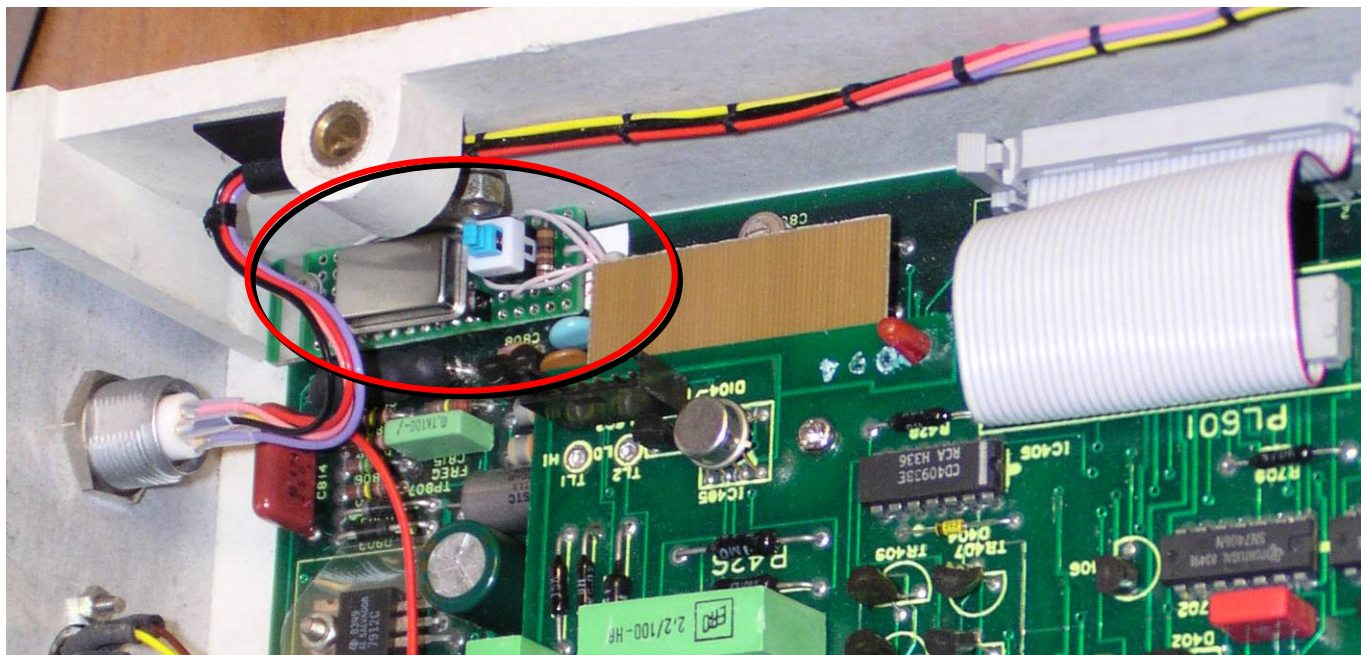
**10/2012** To reduce the noise of the ADC, a mezzanine board with a clock generator was installed at a fixed frequency of 10.48576 MHz and a button for switching to a standard oscillator with a PLL.

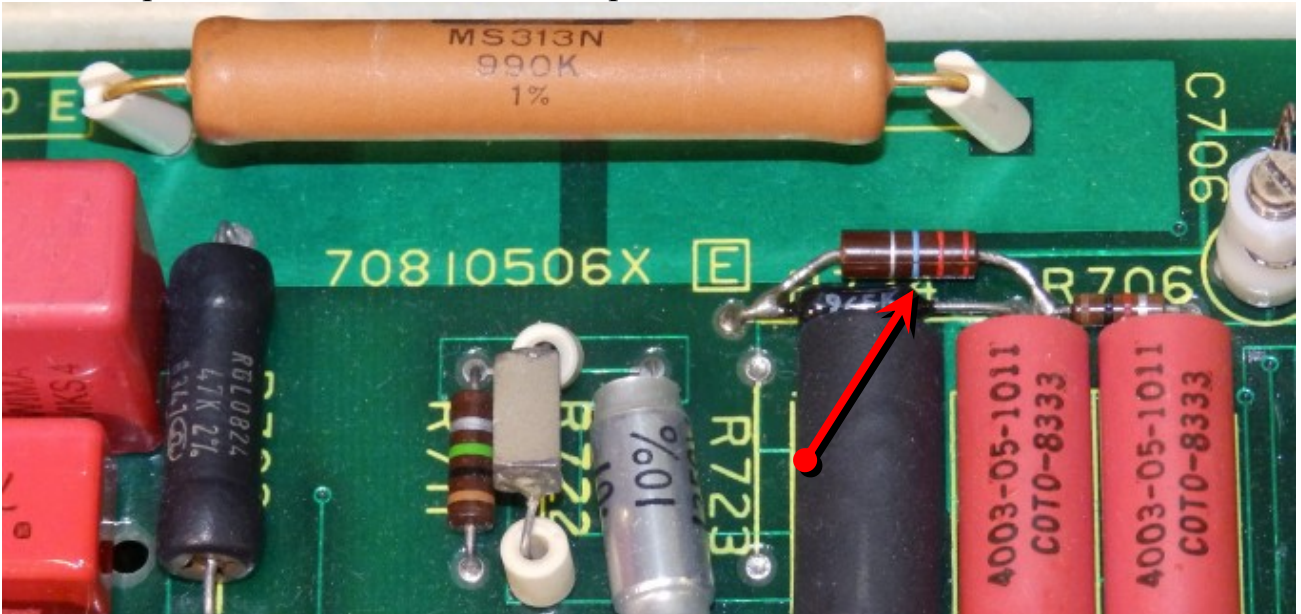
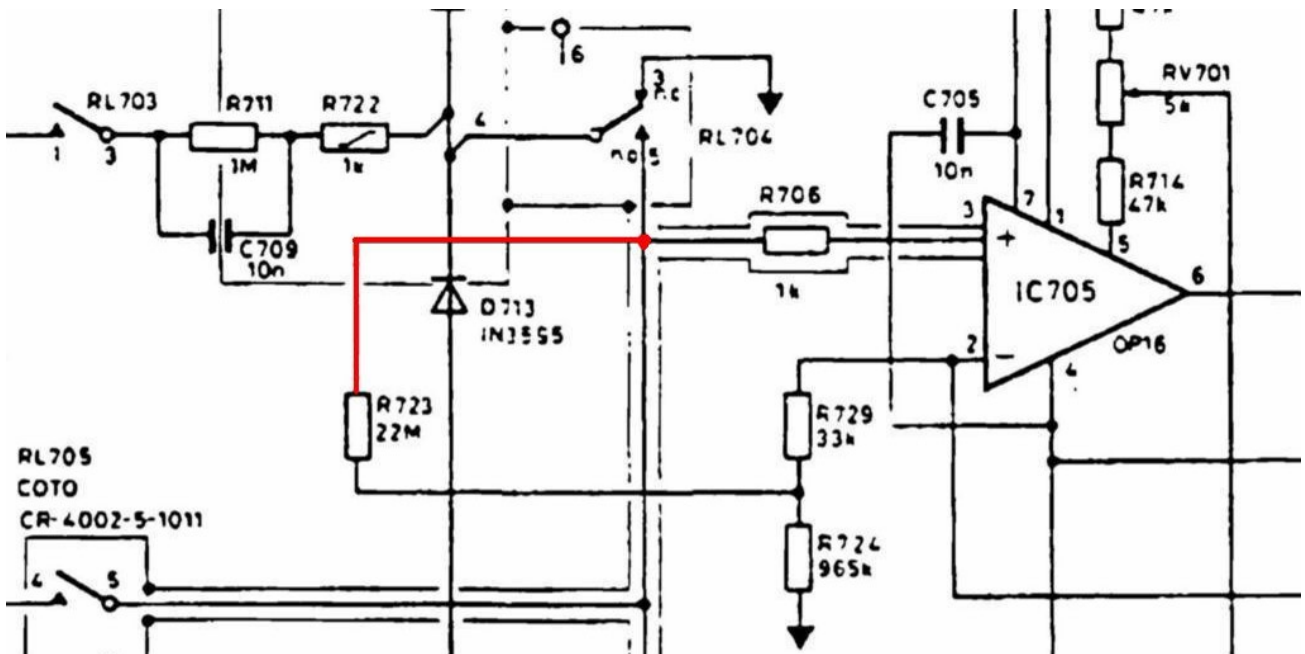
**12/2012** To reduce interference, R723 in the ACV circuit was moved to the same location as it occupies in the final revision of the printed circuit board.

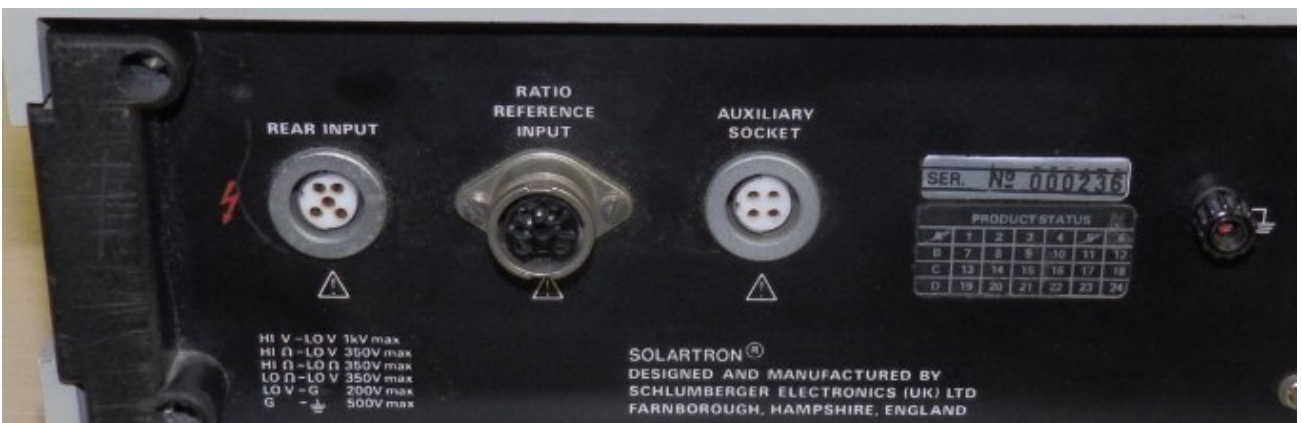
**07/2013** Replaced OP97 with OP07EZ because 2 times less low-frequency noise. Replaced C303-C306 in the voltage reference, the places of soldering were varnished. The AUXILIARY connector on the back of the enclosure was re-purposed for monitoring +7 V (LTZ1000), +10 V and -10 V (voltage reference) in tests of long-term stability.

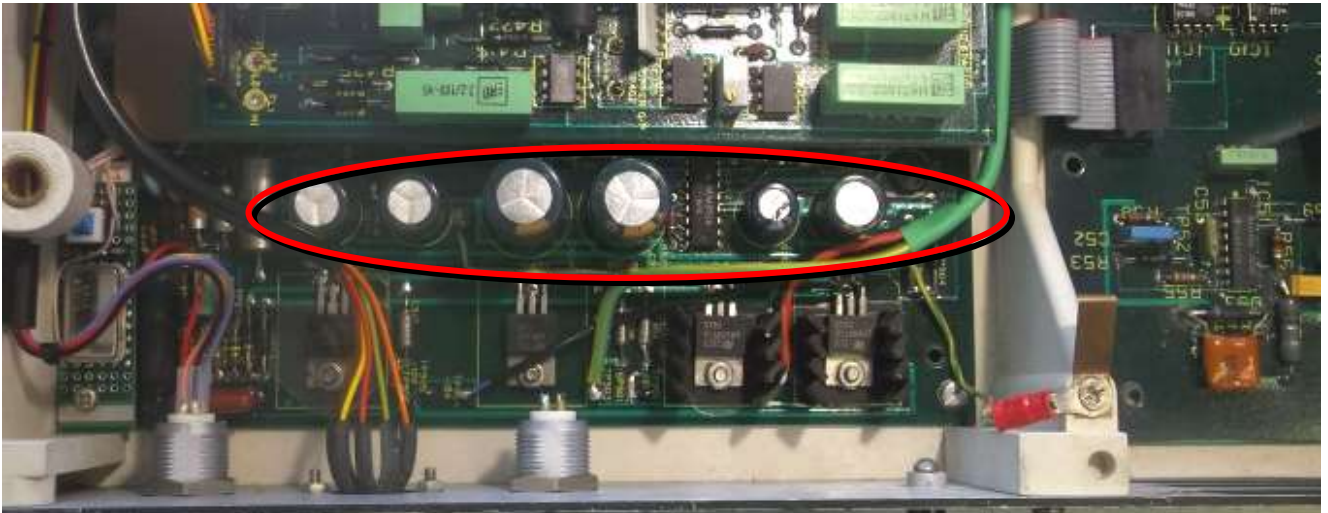
**02/2014** Installed additional bypass capacitors in the +5V floating logic power supply to reduce switching emissions. Electrolytic capacitors of isolated power supply are replaced with low-ESR ones.

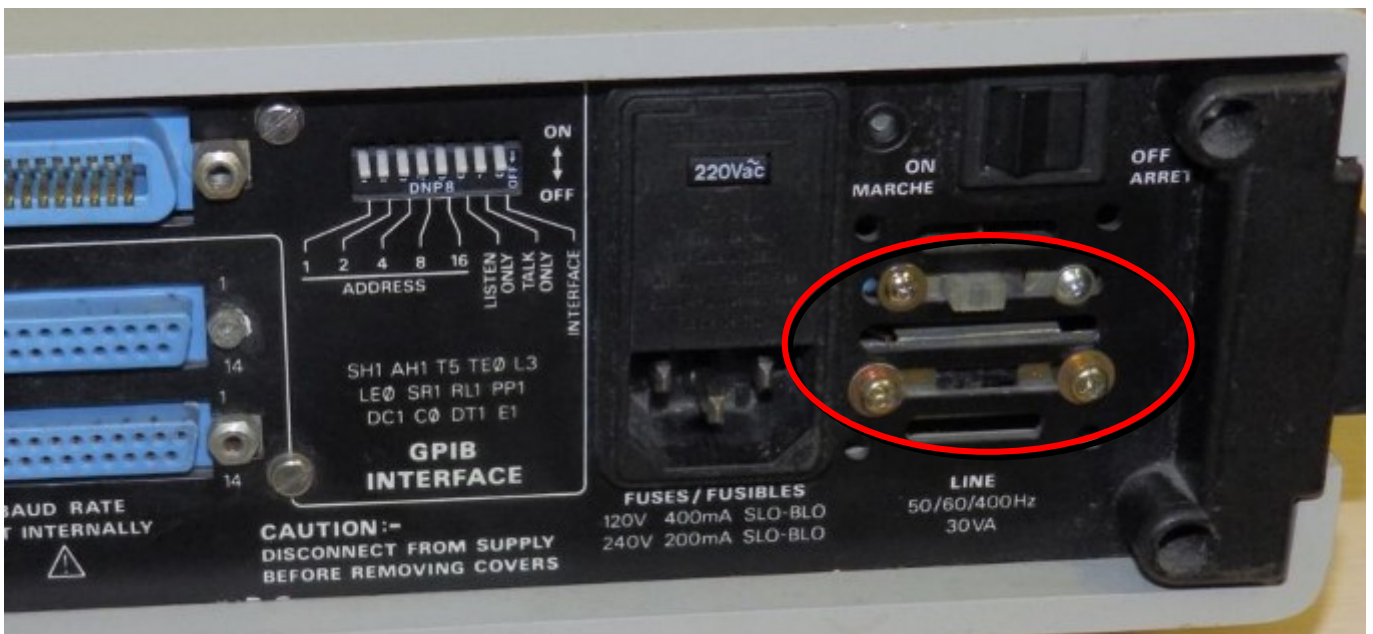
A slide switch was installed on the rear wall case to cut the supply to the heater circuit of the VFD so it could be turned off when not needed so as to increase its service life.

A slide switch on the rear wall of the housing was installed between the chassis of the device the internal shield (sputtered) from the grounded midpoint of the earthed line power filter. Used only in case of emergency when power supply of the device from a 2-wire network without protective ground in order to avoid the risk of  $\frac{1}{2}$  mains potential on the internal screen.

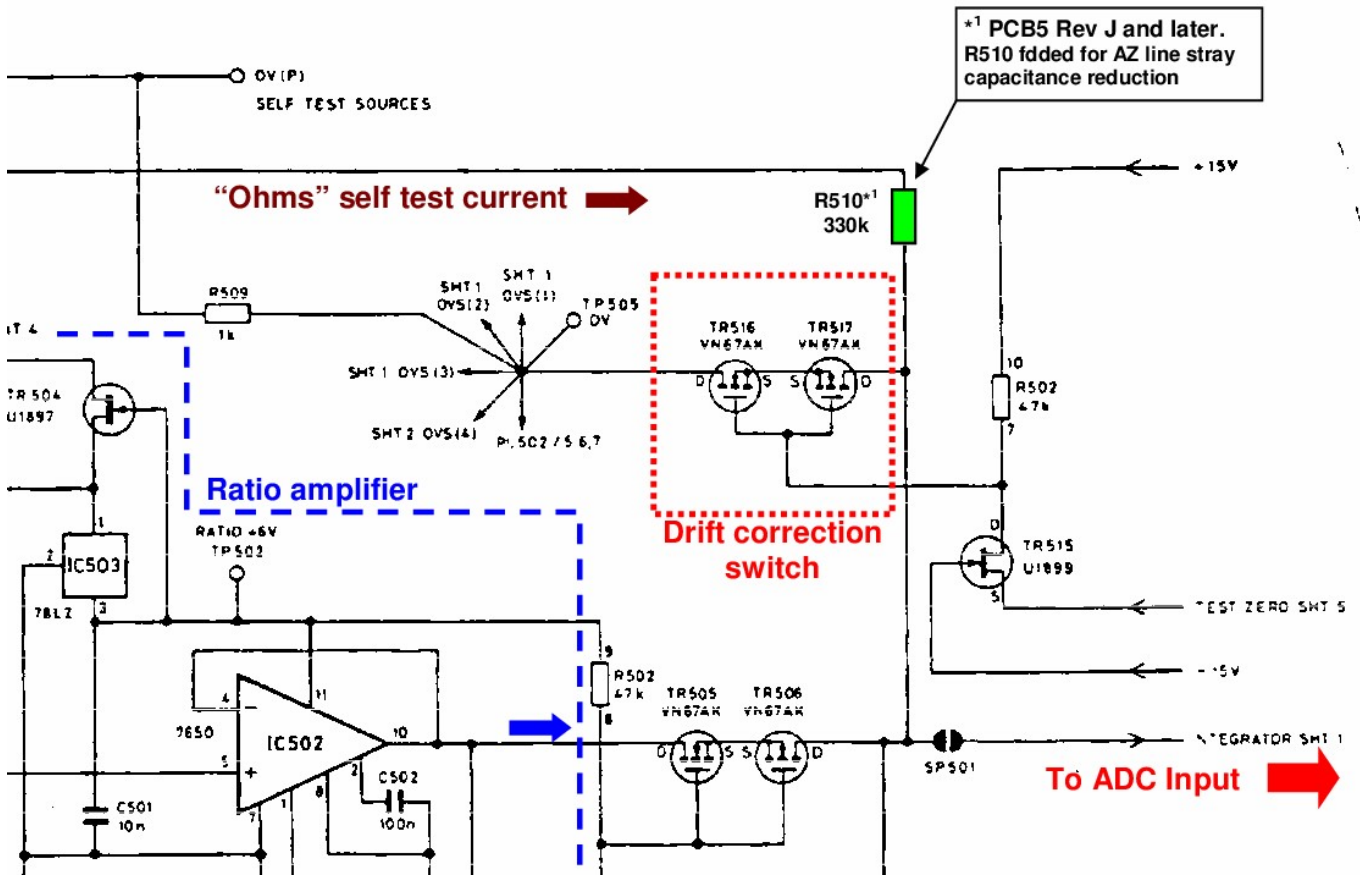
**08/2015** The connection of the GUARD circuit was changed to match the final revision of the schematics. Electro-static screens now connect to the 0VP power zero. GUARD is disconnected from electrostatic screens and inter-winding screens of the power transformer.

08/2015 Added resistor R510 (330 kOhm) to PCB5 board as shown in the final version of the schematics. This is needed to reduce the impact of the capacitance of conductors for the duration of transients during auto-correction zero ADC.

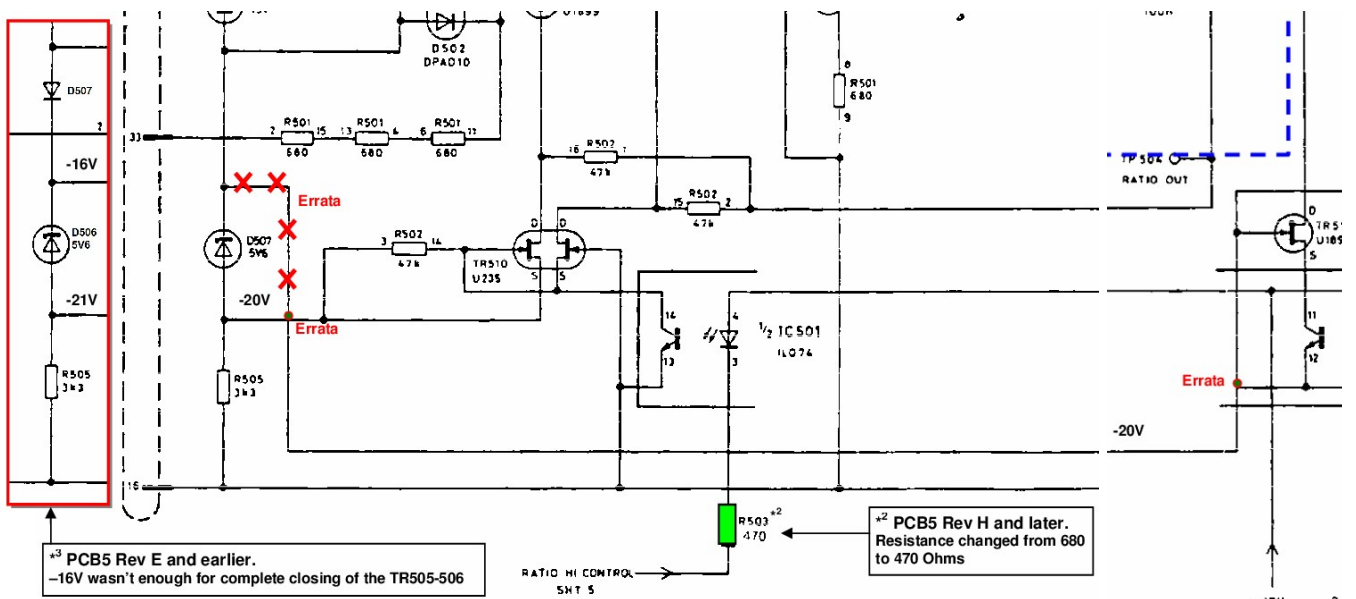
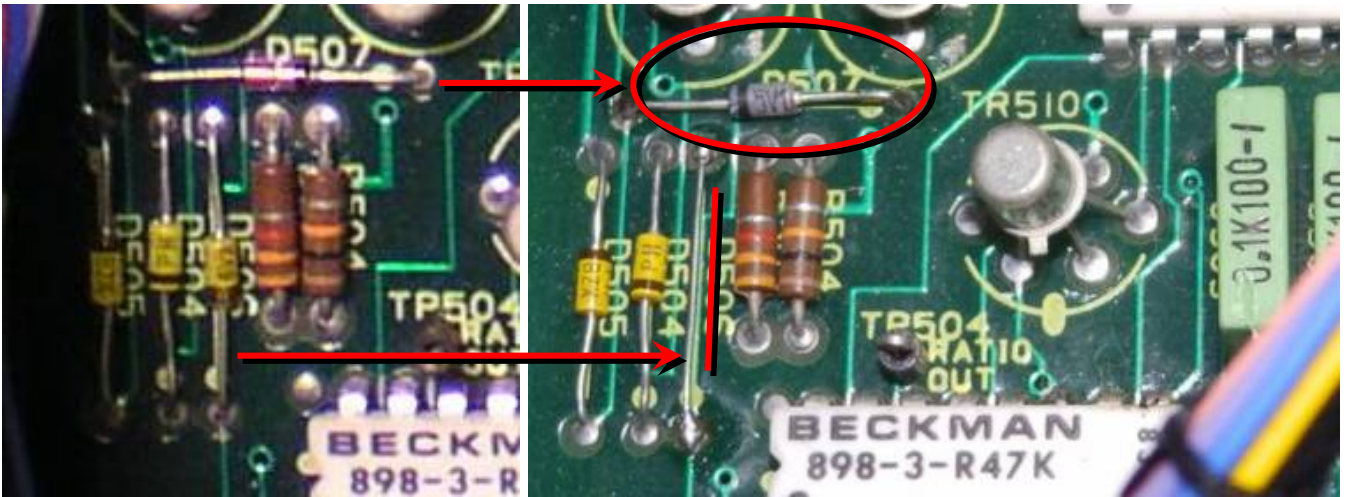
08/2015 The circuit for switching on the D505 and D507 on the PCB5 board is adjusted to create a potential of minus 20 V, thus completely shutting off TR505, 506, 508, 509 and preventing the influence of interference over the input of the RATIO on the measurement results at the main input. The diagram corresponds to the last revision.

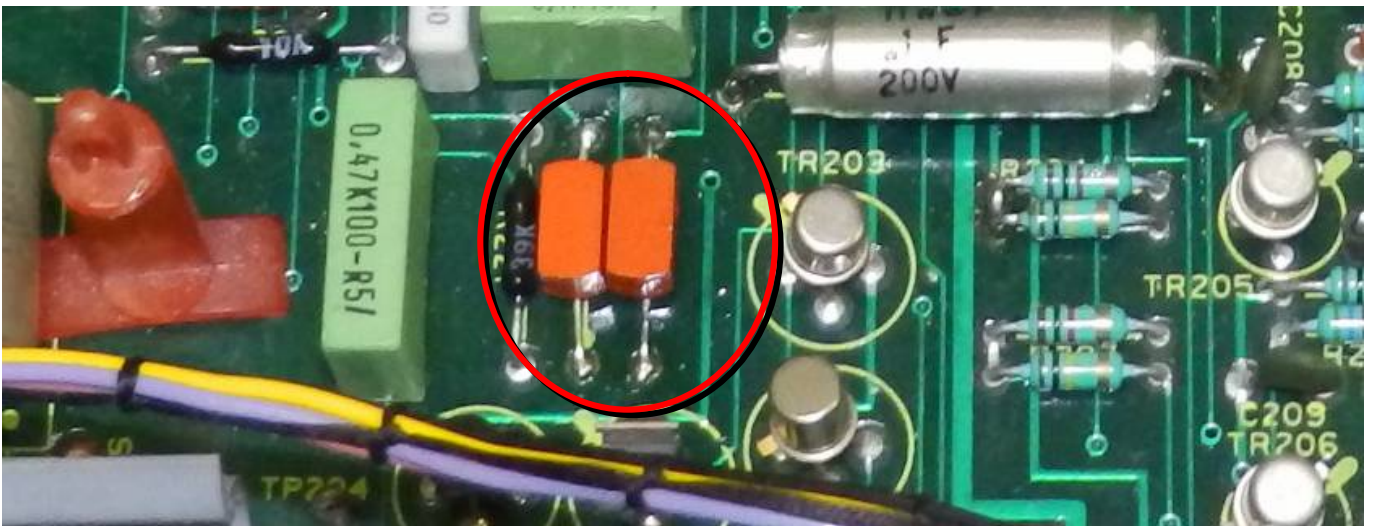
**08/2015** Removed board with voltage regulators LM78L08 and LM79L08 and re-installed the original Zener diodes in the supply circuits of IC201.
