Heath Canyon Landslide

June 03, 2009

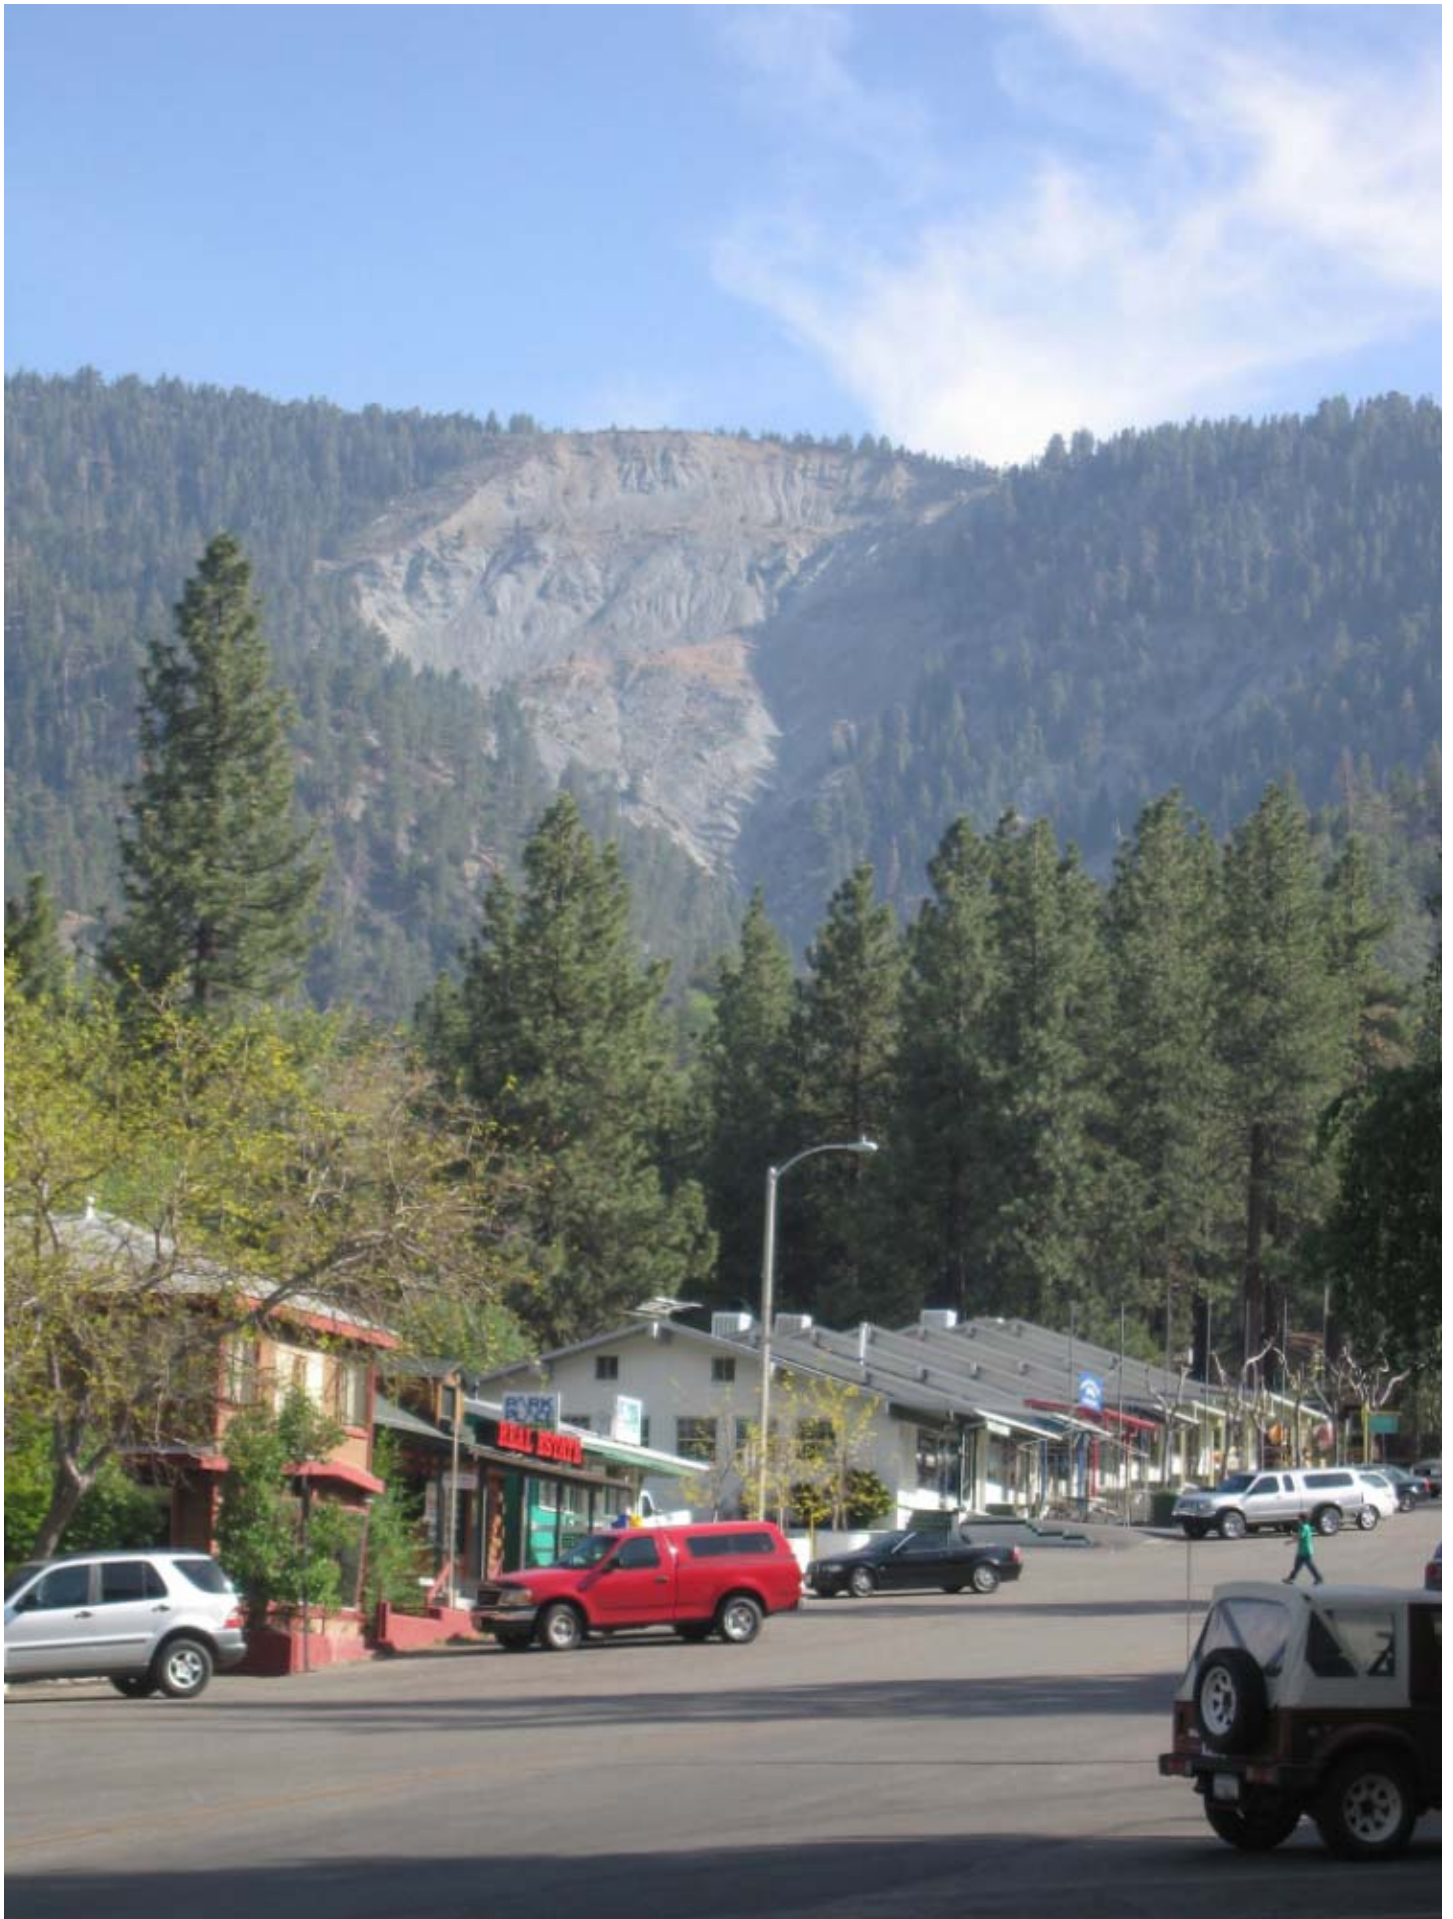
Overlooking the village is a stark, steep, treeless hillside (photo at top). This is the Heath Canyon Landslide, a barren exposure of Pelona schist that produced the [Wrightwood Mudflow](#). In May of 1941, a sudden warming melted the snowpack, lubricating the already weakened schist. The hillside began to slide and formed a massive [mudflow](#). For several days the thick, viscous mud rolled through the eastern part of town and destroyed many homes. The slurry continued north in waves down Sheep Creek Canyon and more than 25 km (15 mi) out onto the [Mojave Desert](#). Even today satellite photos of the area show the dark schist of the Sheep Creek Fan superimposed upon the light tan desert soil (photo at bottom).

The village of [Wrightwood](#) in the [San Gabriel Mountains](#) of southern California sits squarely on the [San Andreas Fault](#) (SAF). A number of prominent fault features run through town including [scarps and sag ponds](#). The southern part of the village sits on [the Pacific Plate](#). The rock here is mostly [Pelona schist](#) and [actinolite](#). On the north side of town, on the [North American Plate](#), the rock is primarily ancient [gneiss](#). Movement along the SAF has placed the two different rocks together. At the same time, the grinding motion has profoundly fractured the rock, and [fault gouge](#) is widespread throughout the area.
