09/2011 The failed NiMH battery backup supply for the SRAM on the earthy logic board was replaced. The charge current for the new, higher capacity battery was increased to 7mA from 0.8mA by changing R403 from 1.8kΩ to 200Ω. The RTC battery was also replaced. The boards and connectors were cleaned of corrosion marks.

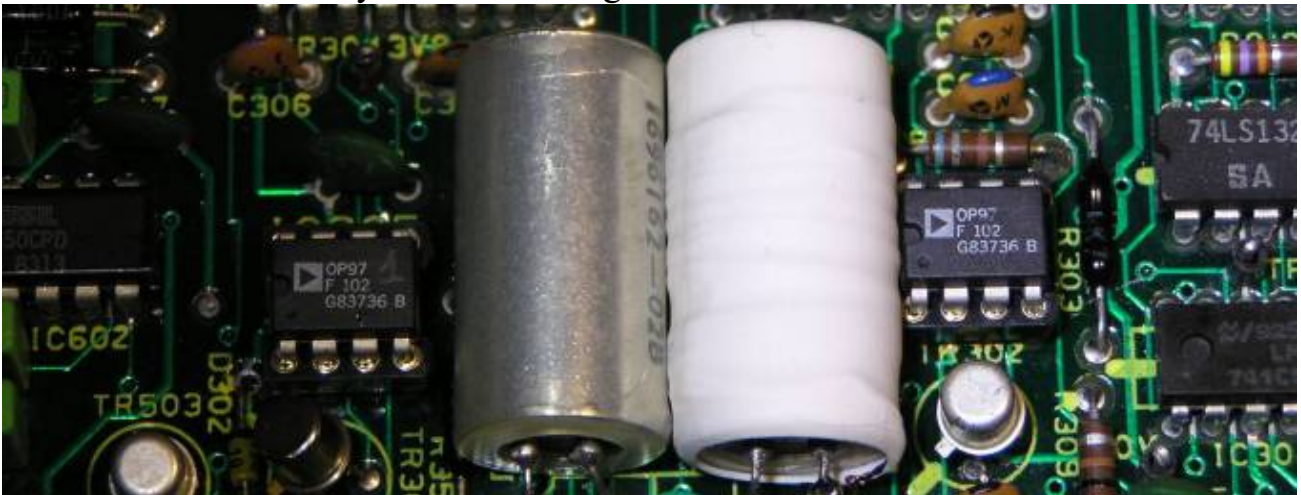
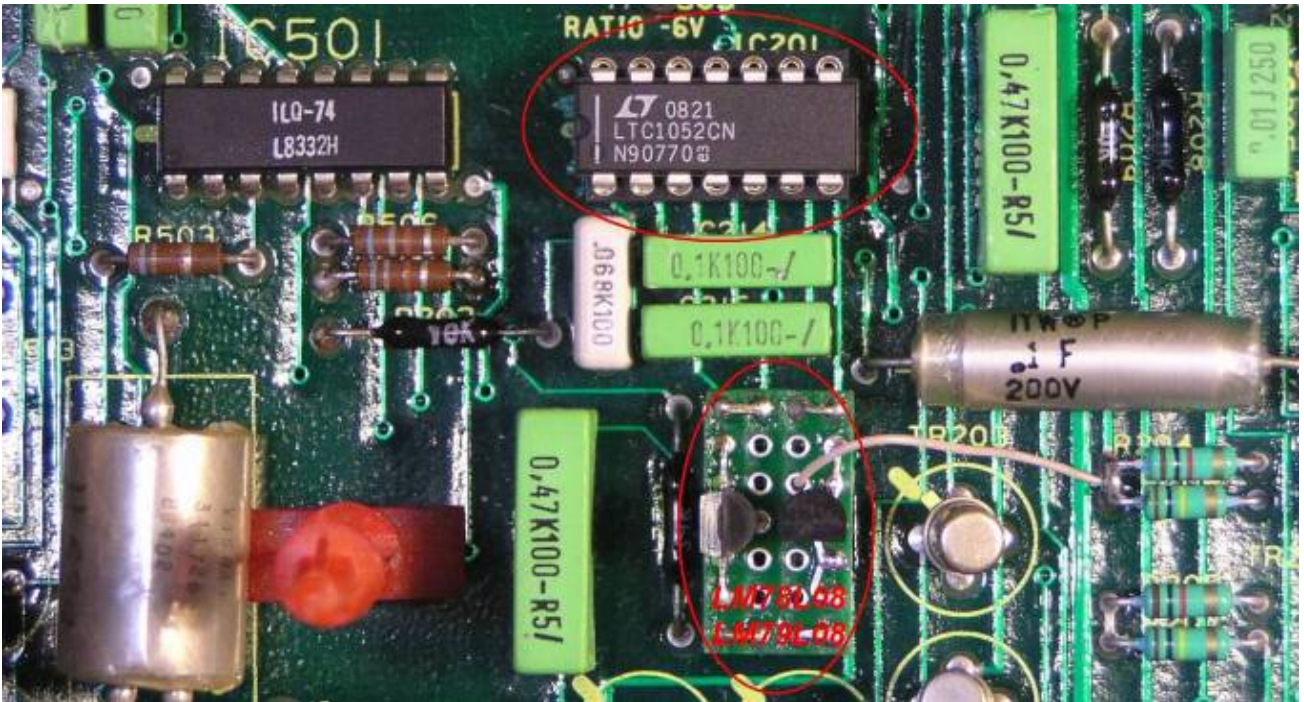
**01/2012** A problem of a large zero offset drift was found in the instrument readings as the instrument warmed up from a cold start with a shorted input to the ADC.

Op-amps IC305 and IC306 (OP07EZ) were replaced with OP97F in sockets. Op-amp IC201 (ICL7650CPD) was removed, and temporarily replaced with an LTC1052CN. The Zener diodes in the power circuits of Op-Amp IC201 were replaced by linear regulators LM78L08 and LM79L08 with smoothing capacitors. R305 was removed and the TCR for each half was measured. They were found to be different. This was adjusted by bifilar winding 0.99 m of 0.25 mm diameter copper (measured resistance 0.43 Ohms) over the case of R305 and connecting it in series with the lower end of R305b.

The drift was reduced by an order of magnitude.

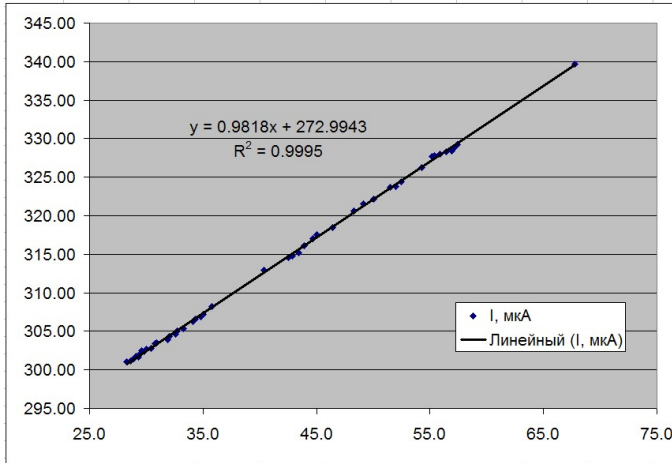
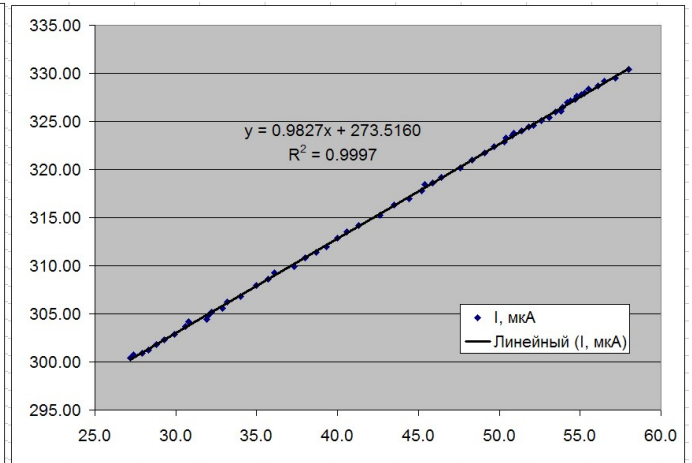
**03/2012** A new AD590 temperature sensor was purchased. Measured parameters transfer function of the new sensor as compared to the regular temperature sensor D351.

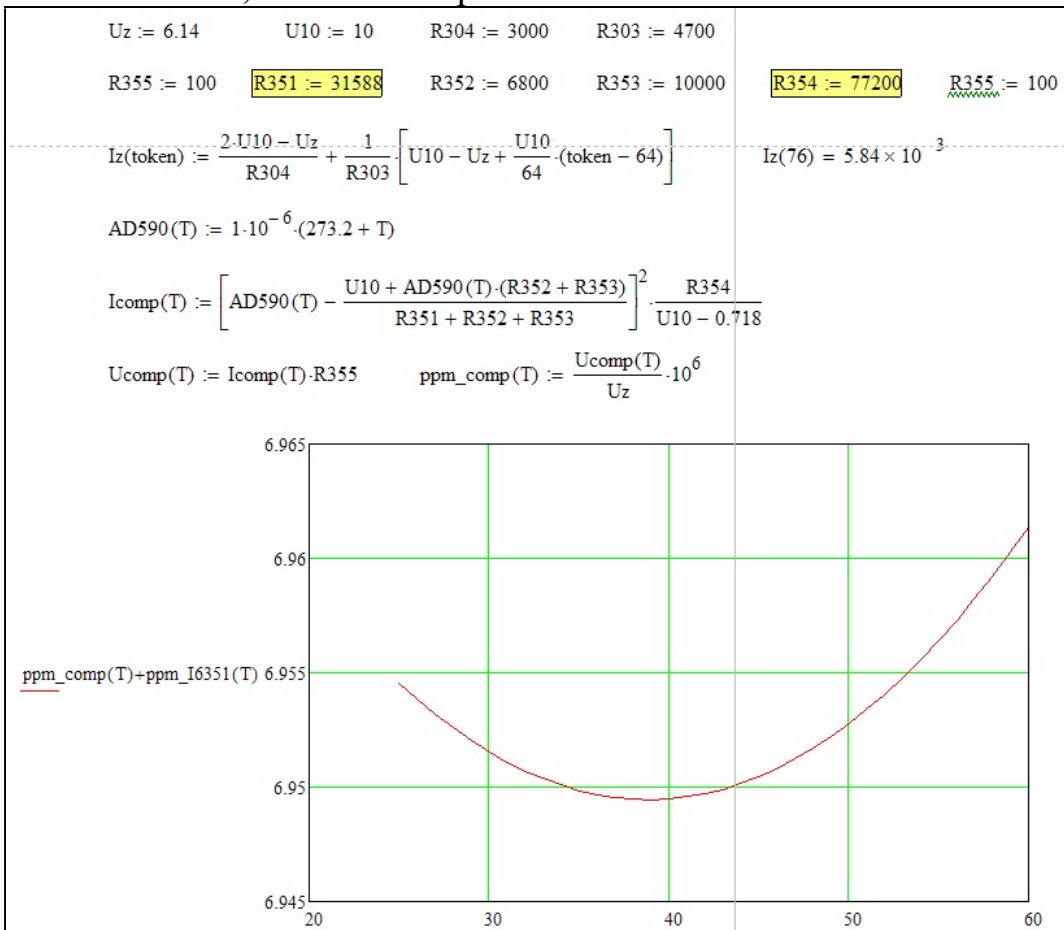
Using the contour current method, a mathematical model was derived of the parabolic temperature compensation as a function of the correction current (voltage) from the set point of the DAC, the Zener diode, the AD590 sensor, the values of resistors R303, R304, and R351-R355, and the multiplier.
