AIRBUS

The Airbus Safety Magazine	1
News	2
C. Courtenay	
Near CFIT event during Non Precision Approach	4
P. Charalambides	
A320 Tail strike at Take-Off?	10
M. Baillion	
<u>Unreliable Speed</u>	14
J. Barthe	
Compliance to operational procedures	20
C. Pelegrin	
The Future Air Navigation System FANS B	24
S. de Cuendas	
Airbus Flight Safety Contacts/Organisation	32

Safety First

Near CFIT event during Non Precision Approach

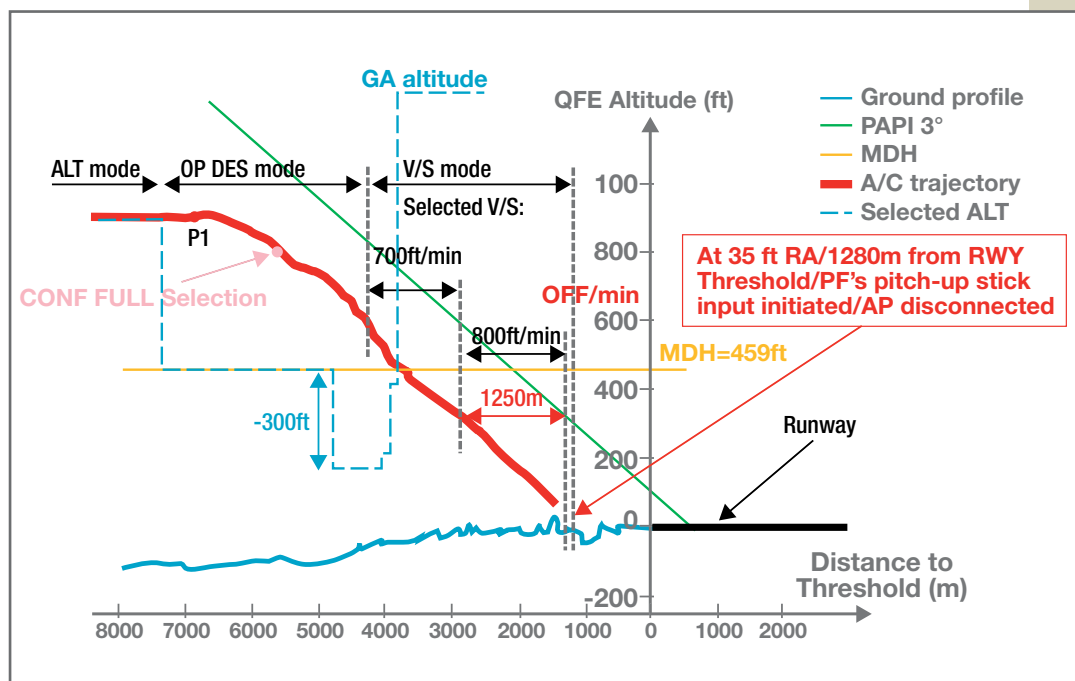
Descent profile

The figure here below presents the descent profile from "P1"

This sequence can be detailed as follows:

- Shortly before over-flying "P1", MDA altitude was selected on the FCU, and the OP DES longitudinal autopilot mode was selected so that a thrust reduction was progressively commanded to target idle thrust, while the autopilot pitch mode maintained the speed target.

- At that stage the aircraft was in slats/flaps configuration 3, gear down, both flight directors engaged, autopilot N°2 engaged.
- For the whole approach the autopilot lateral mode remained in NAV mode.

- **At 800ft QFE, 3NM from runway threshold**, shortly after over-flying the last altitude constraint "P1" full slats/flaps configuration was selected.

- **At 680ft QFE, 2.6NM from runway threshold**, whereas the rate of descent was 1000ft/min, an altitude 300ft below MDA was selected on the FCU.
- **At 600ft QFE, 2.3NM from runway threshold**, while the current rate of descent was -1400ft/min, the crew selected the autopilot V/S mode with initially a selected V/S of -700ft/min. From that time auto-thrust was therefore engaged in speed mode. Target speed was Vapp (VLS +5kts).

- While descending **below MDA about 2.1 NM from runway threshold**, go-around altitude was selected on the FCU.
- **At 325ft QFE/ 1.54NM from runway threshold**, the crew selected a vertical speed of -800ft/min.
- **At 47ft RA at about 0.72NM from runway threshold** the crew selected a vertical speed of 0ft/min.
- **At 35ft RA, at 0.70 NM from runway threshold**, the Pilot Flying applied 2/3 of full back stick input that disconnected immediately the autopilot.

- 1/ As this approach was performed in GPS primary (In this case only GPS and IRS data are used for the aircraft position computation) the accuracy of the recorded aircraft position is very good.
- 2/ In managed guidance only (FINAL APP mode engaged) when the aircraft reaches MDA (MDH) -50ft or 400ft (if no MDA/MDH entered) the autopilot automatically disengages.
- 3/ As noticeable on the figure here above, from MDA altitude this final descent was performed on a 3° slope.

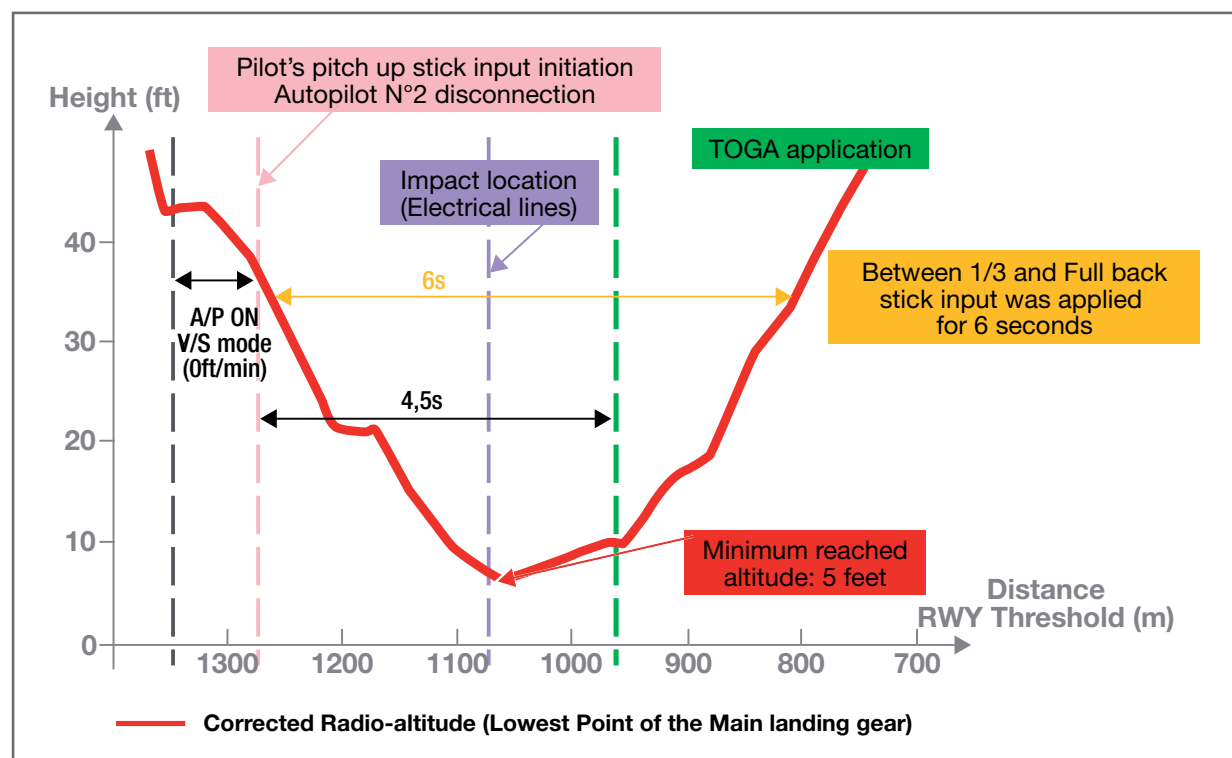
Zoom on pilot's take-over phase

The figure here below presents a zoom on the pilot's take-over phase:

- The radio-altimeter parameters recorded in the DFDR (here plotted in red) indicate the distance between the lowest point of the main landing gear and the ground.

- The initial PF's pitch-up stick input was followed by permanent pitch-up stick input (between 1/3 and full back stick input) applied for 6 seconds, so that the aircraft stopped descending and started to climb.

- Minimum recorded altitude was 5ft RA reached at about 1100m from the runway threshold.
- The estimation of the impact location indicates that, at that moment, the aircraft impacted the electrical lines.

- At 10ft RA, 4.5 seconds after the initial PF's pitch-up stick input, thrust levers were moved forward to TOGA detent.
- 43 seconds after TOGA application, landing gears were selected up.

- 2 minutes after TOGA application, Slats/Flaps configuration 3 was selected.
- The aircraft diverted to the scheduled alternate airport.

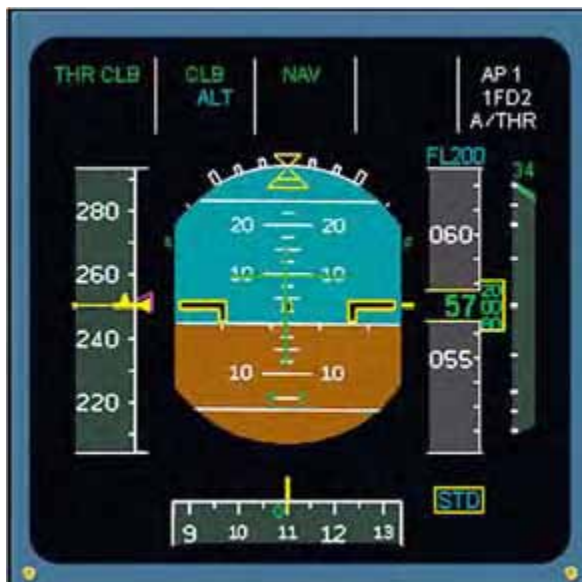
CAPT PFD

The consequences of this erroneous pressure information, once used by the ADRs and/or the standby instruments, are the computation and the display of unreliable speed and/or altitude for all users.

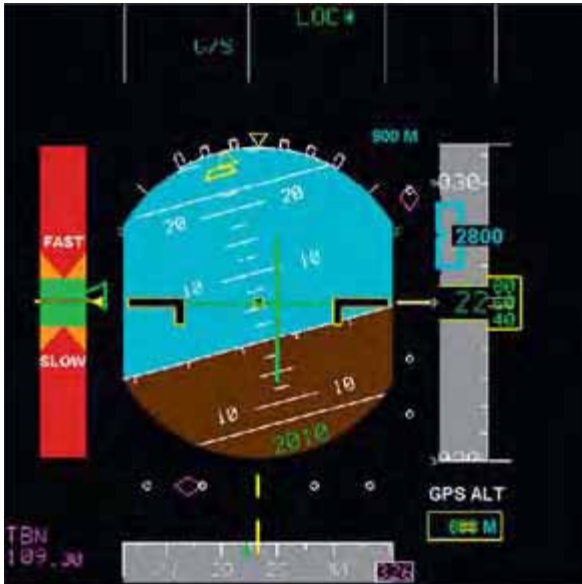
- The Back-Up Speed Scale replaces the PFD speed scale on both PFDs,
- GPS Altitude replaces the Altitude Scale on both PFDs.

The Back-Up Speed Scale then enables to fly at a safe speed, i.e. above stall speed and below maximum structural speeds, by adjusting thrust and pitch.

Buss: "Fly the green"

The BUSS will be displayed once all ADRs are switched OFF. Therefore, on aircraft that have the BUSS, when the flight crew cannot identify the faulty ADR(s) when performing the troubleshooting, or when all ADRs are affected, the flight crew will switch OFF all ADRs, and will fly the green area of the BUSS.

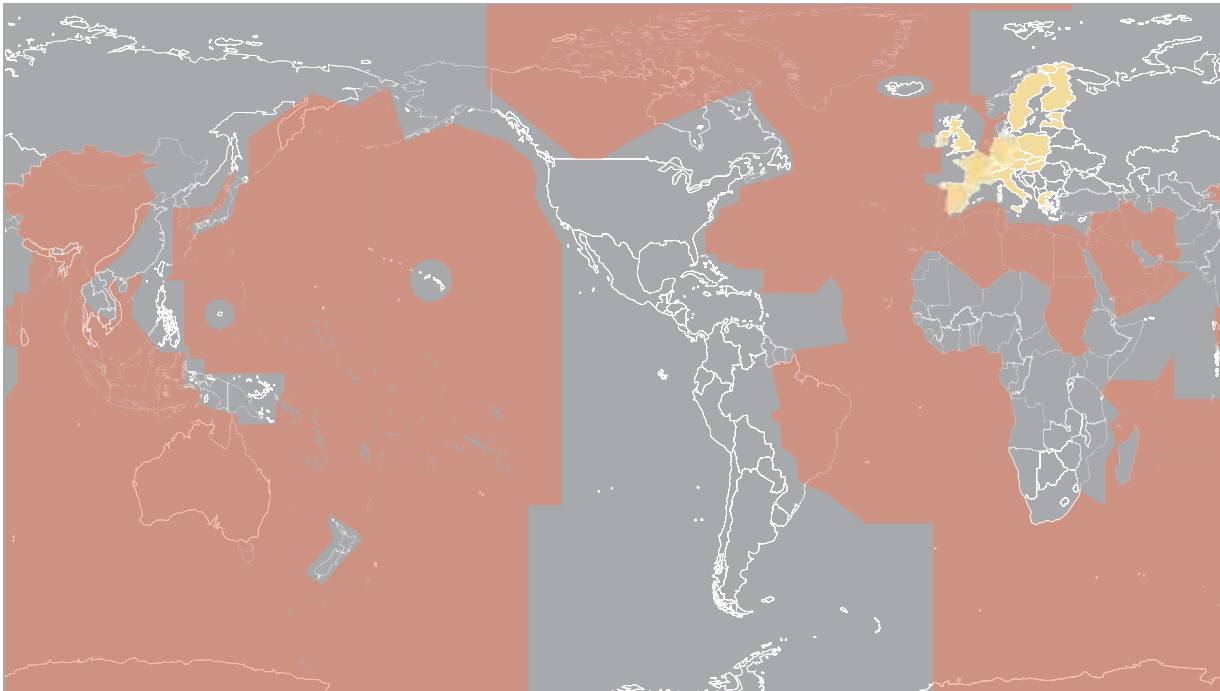
2007 Worldwide air traffic data link services

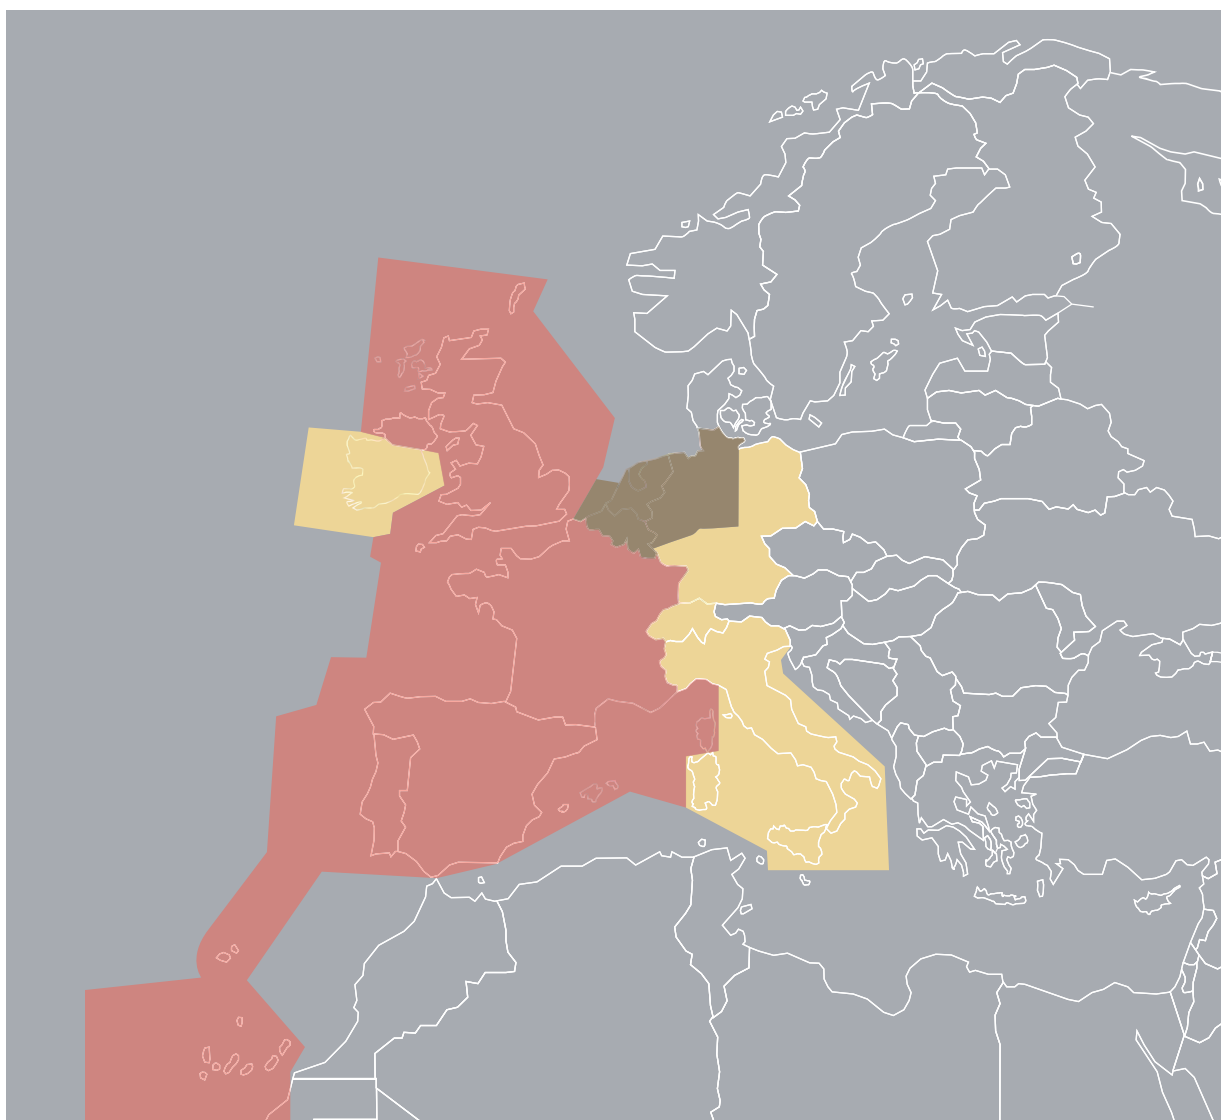
ANSP implementation plan

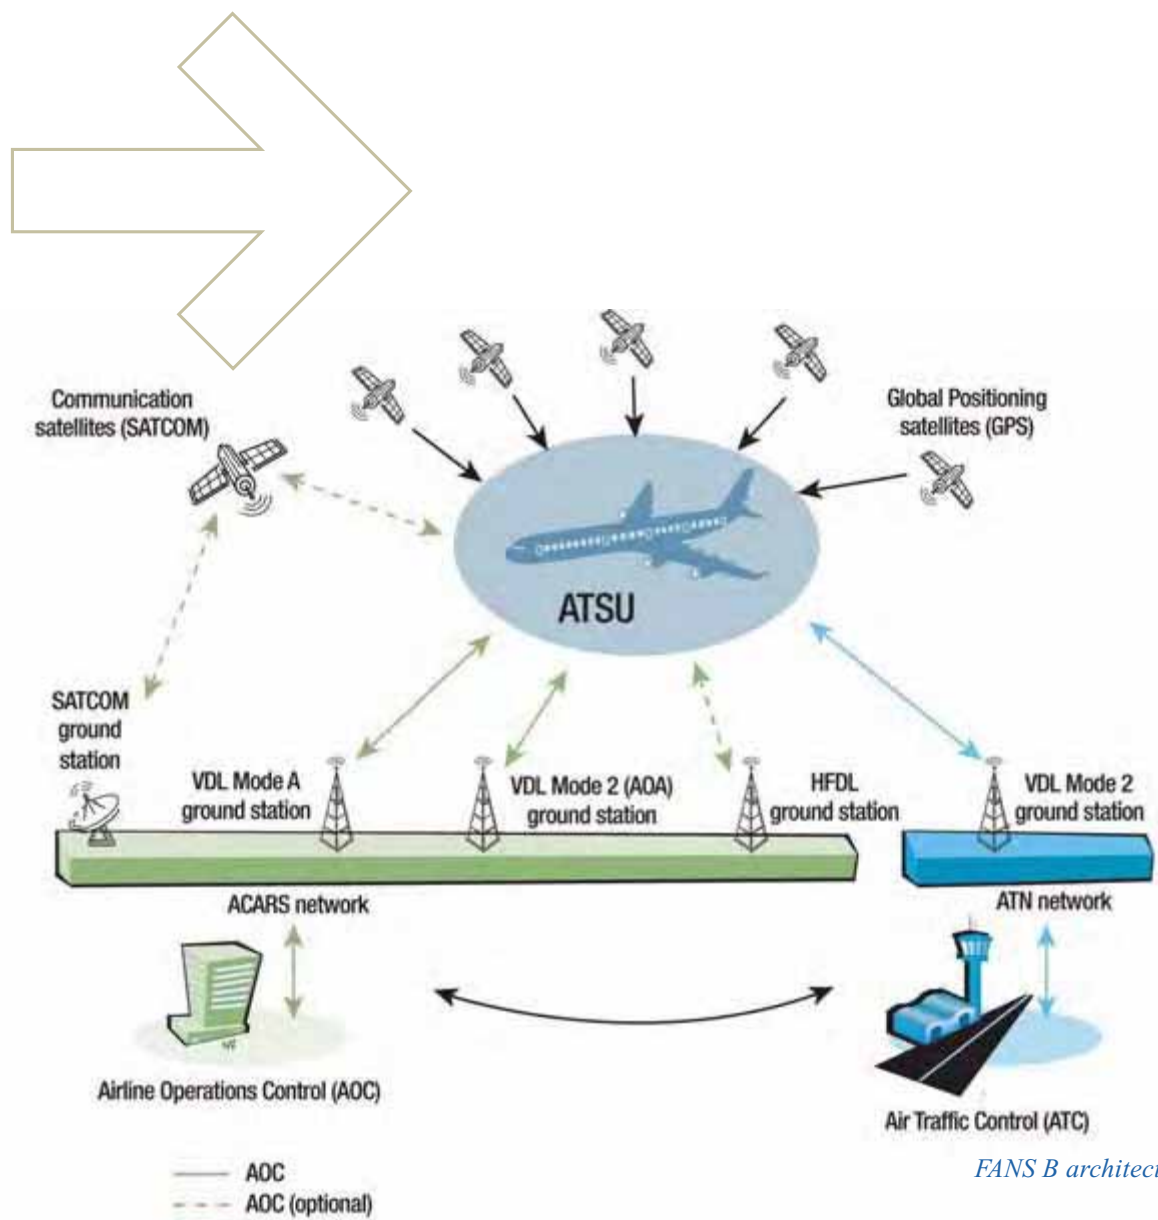
The Airbus FANS B product offers, at aircraft level, over ATN air-ground communication network and through VDL Mode 2 sub-network, the data link applications and services (Context Management Application, Controller Pilot Data-Link Communication application and ATC Communication Management, ATC Clearance, and ATC Microphone Check services) in accordance with Link 2000+ Programme specifications.

FANS B architecture

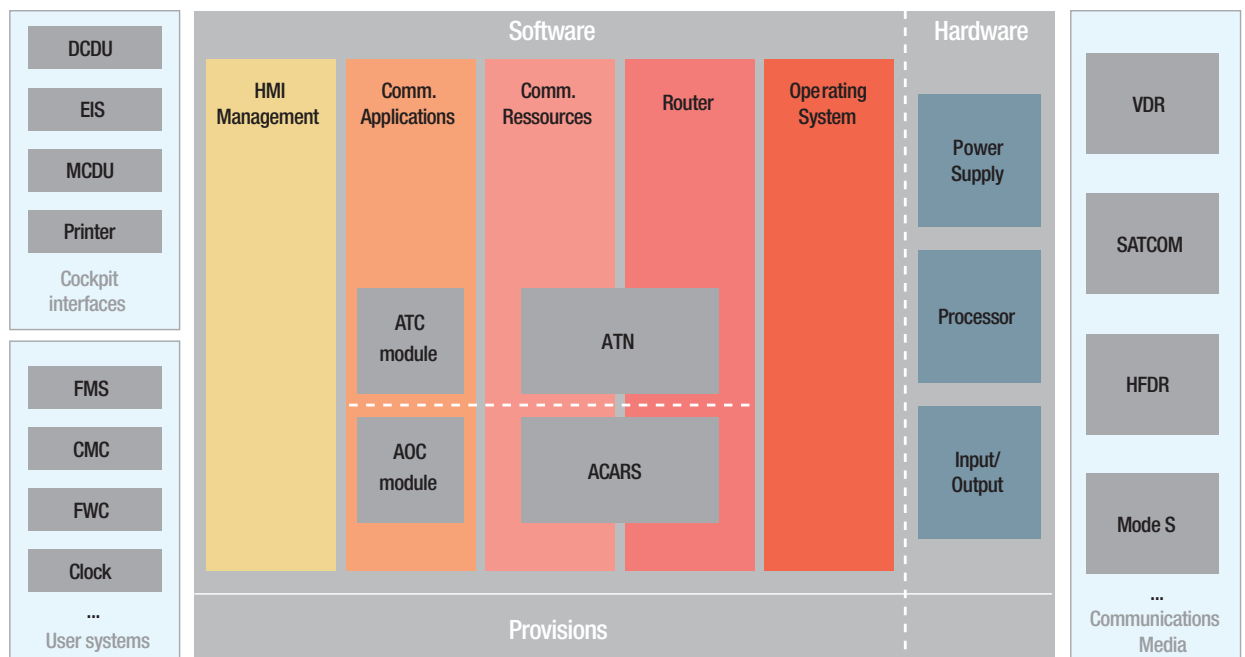
Air Traffic Services Unit - ATSU

FANS B architecture

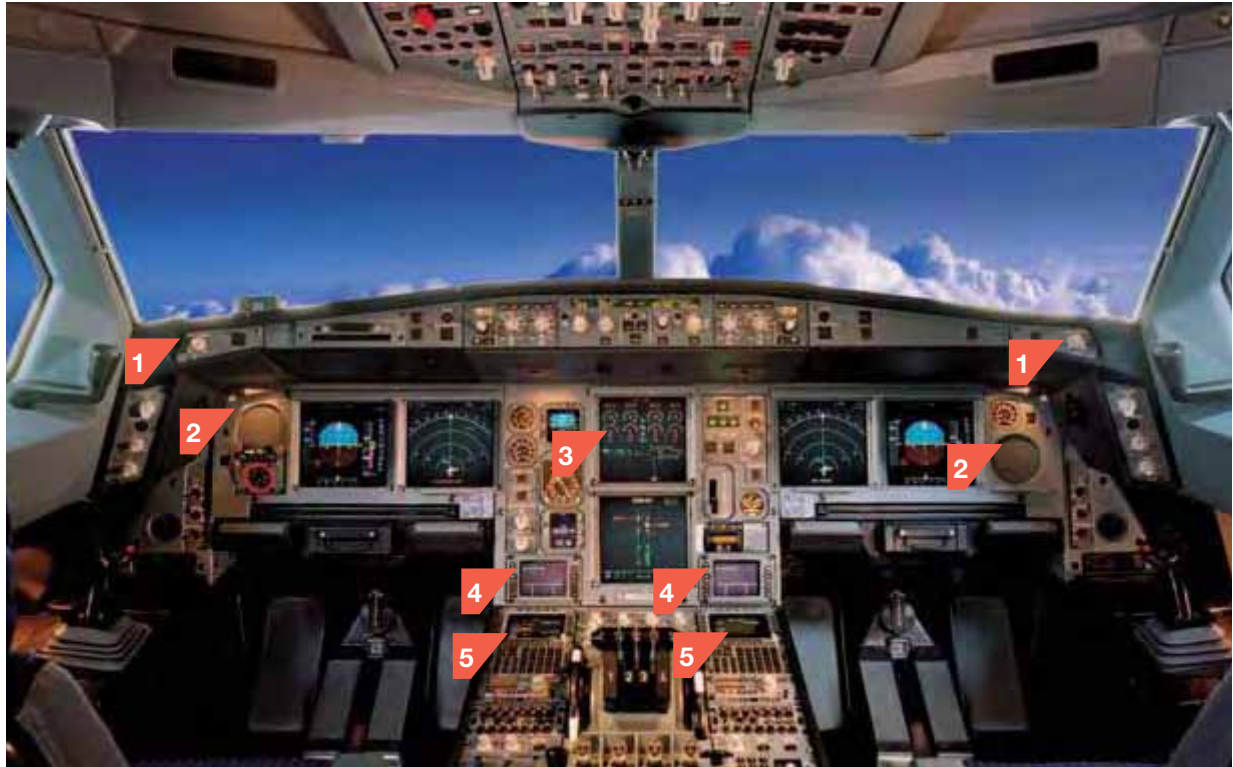
- An aural alert: A specific sound named 'RING' (double brief ringing-phone-like alert)
- A visual alert: Two flashing lighted push-button switches labelled 'ATC MSG' (one for CAPT, one for F/O), located in the glare shield. The flashing period is one second.

1 *Two visual attention getters*

2 *Two aural ATC alerts*
